# FACILITY ASSESSMENT

## TABERNACLE TOWN HALL

**TOWNSHIP OF TABERNACLE**  
**163 CARRANZA ROAD, TABERNACLE, NEW JERSEY 08088**

**RYEBREAD PROJECT NO. 5665B**

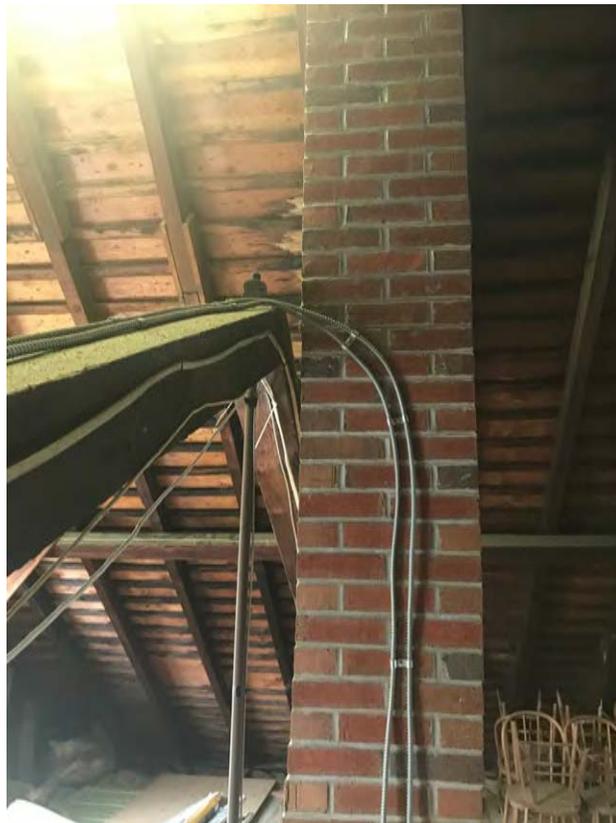
**Roof Flashings:** There appear to be active leaks around the chimney in the attic. Roof level examination of the flashings was not possible, however based upon visual observances, experience tells us there is a breach in the flashing/counterflashing at the chimney. The picture below indicated stained, and possibly deteriorated plywood sheathing around the chimney.

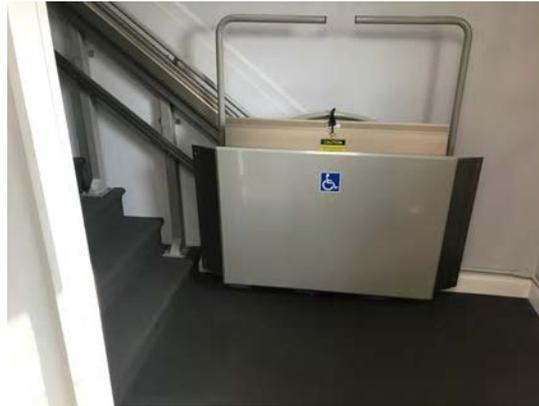
**Front Interior Stairwell:** The Public access to the Upper Level is through an open stairwell between the two levels. A wall-mounted, floor supported chair lift is provided to access to the upper level for persons with mobility issues. We understand the chair lift is in the process of being replaced. Of concern is when the chair lift is in use, it limits the egress capacity of the remainder of the stairwell, potentially creating a bottleneck in the event of an emergency. Access to the Meeting Room has been provided by a chair lift for many years, however, it technically does not meet today's accessibility Codes. Furthermore, egress calculations should be conducted to determine if the proper egress units is provided to allow occupants to safely evacuate

the second floor in an emergency. The IBC/NJ Edition Code Section 1104.4.1.1 states, “Regardless of the square footage of the buildings or floors, buildings of two or more stories that are owned by public entities shall provide a vertical accessible route between floors.”

Chairlift to Second Floor

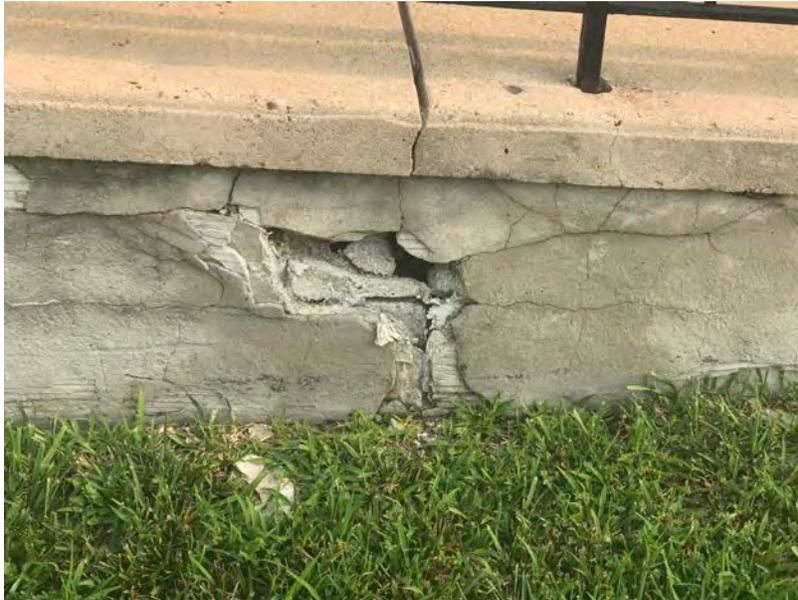
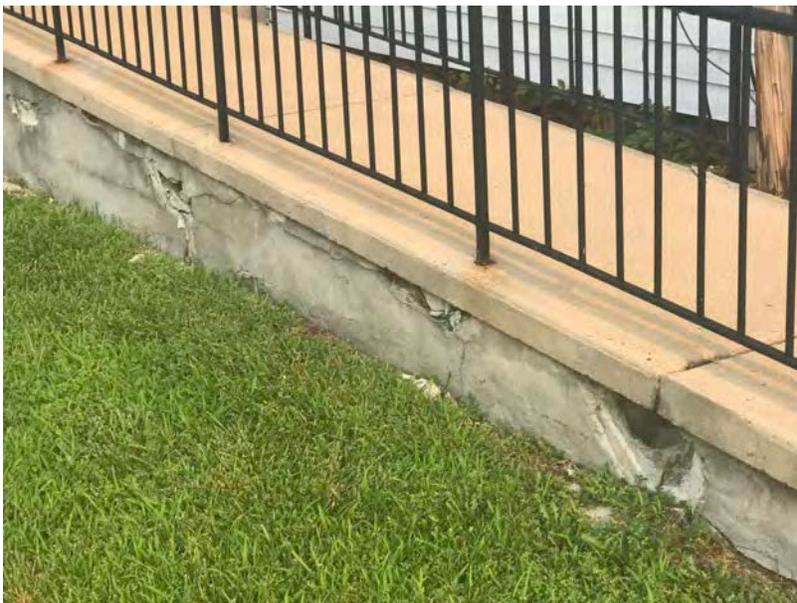
**Sidewalks:** With the exception of the side exit, the sidewalks and walkways are predominately concrete and appear to be serviceable condition. The side entrance ramp construction is failing and should undergo repairs or replacement.

Side Entrance Ramp Deterioration

2.2 The existing foundation wall for the exterior concrete ramp has deteriorated. Repair or replacement of the ramp is required.

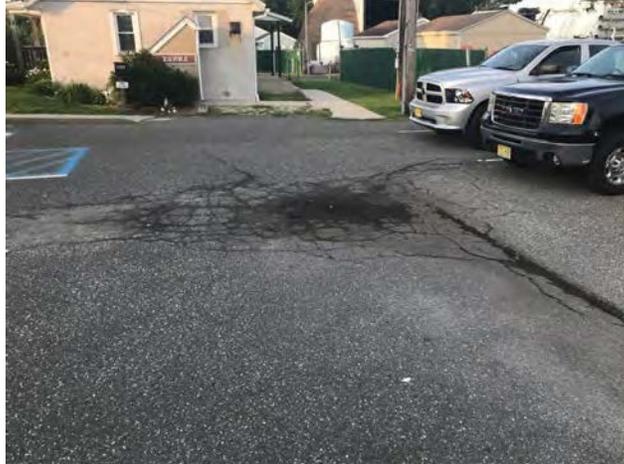
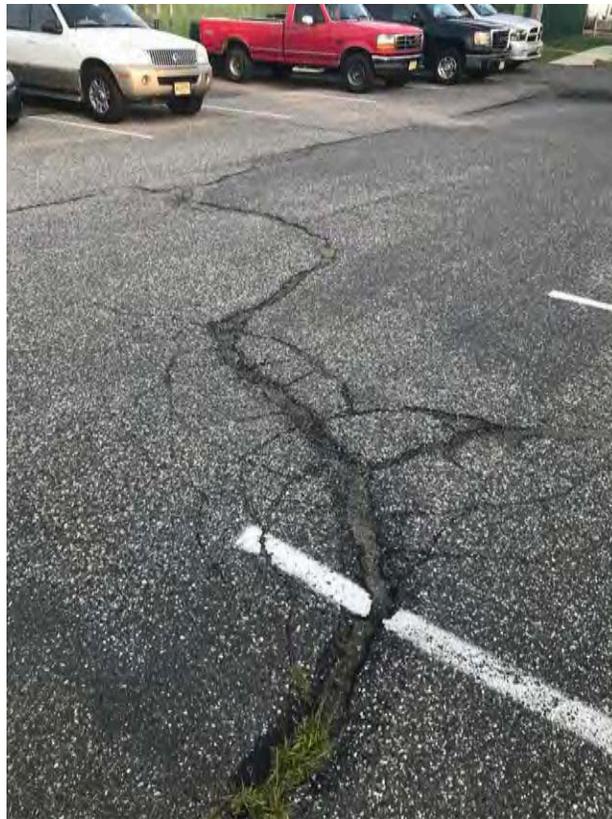
**Condition of Parking Lot:** The parking lot is a shared lot between the Town Hall, Annex and Public Works Department. The asphalt has several cracks and deterioration and the

lot is in overall poor condition. Consideration should be given towards a parking lot repair/replacement/improvement.

Typical Condition of Parking Lot

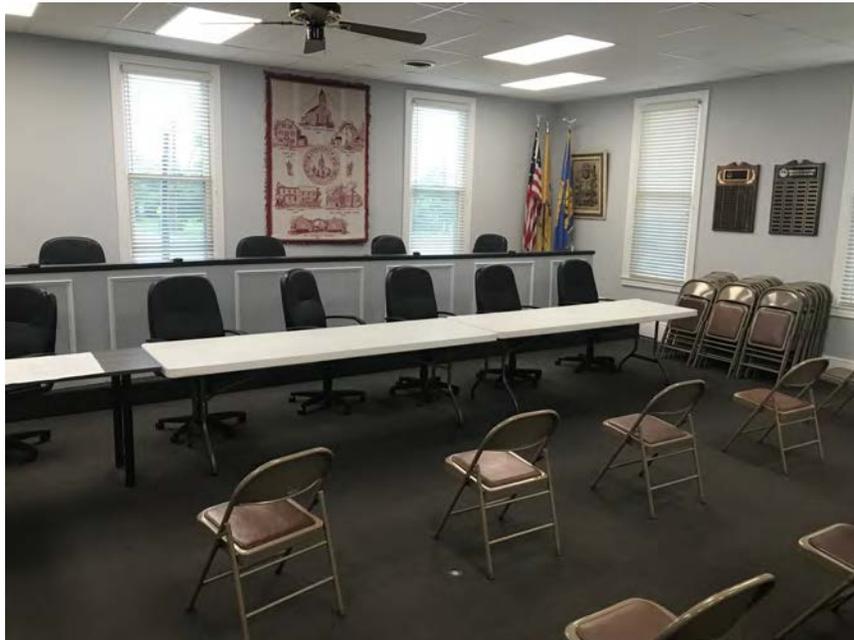
**Meeting Room Function:** The Meeting Room currently operates with elected officials on the raised dais with their backs facing Carranza Road. Additionally, there are three large windows to their backs. Without adequate wall protection installed in the exterior wall, this condition creates a potentially unsafe condition for elected officials.

Meeting Room

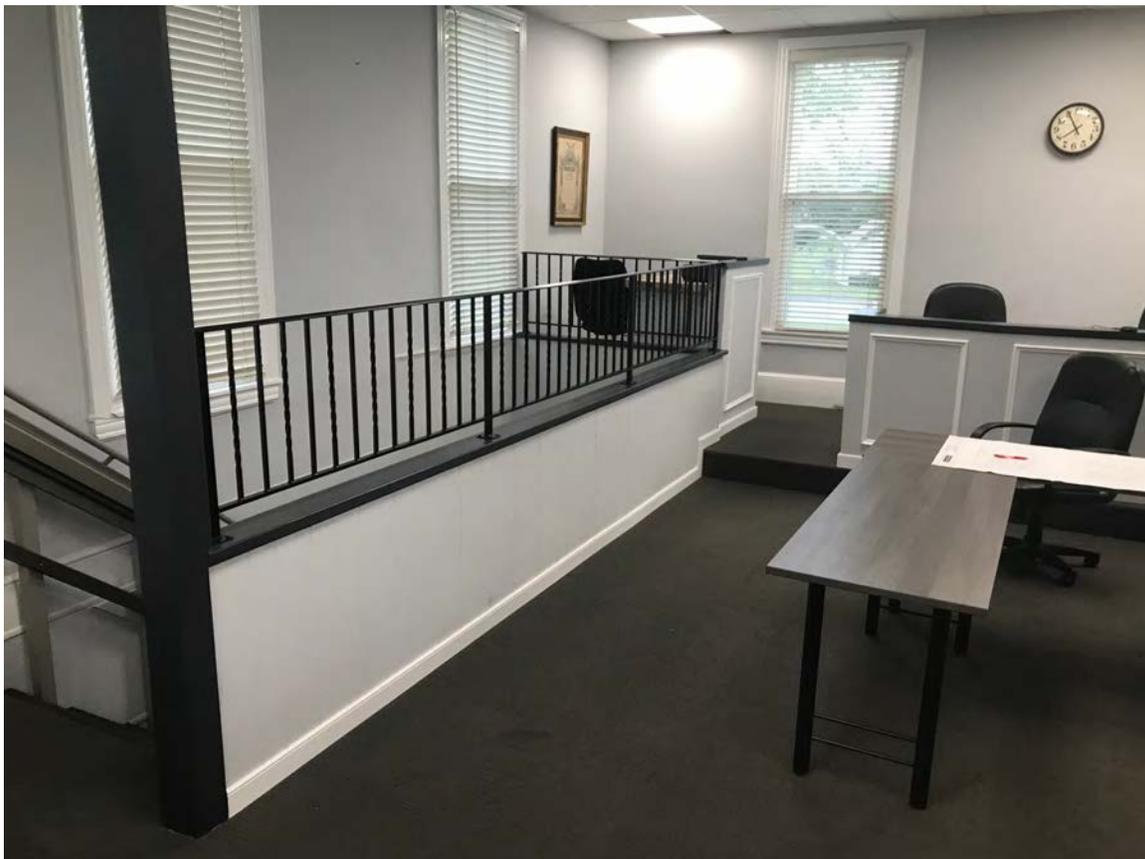
**Meeting Room Dais:** The Dais is on a raised platform without an accessible ramp to access the raised level. A ramp should be installed to provide accessibility to the raised level.

Step up to Dais

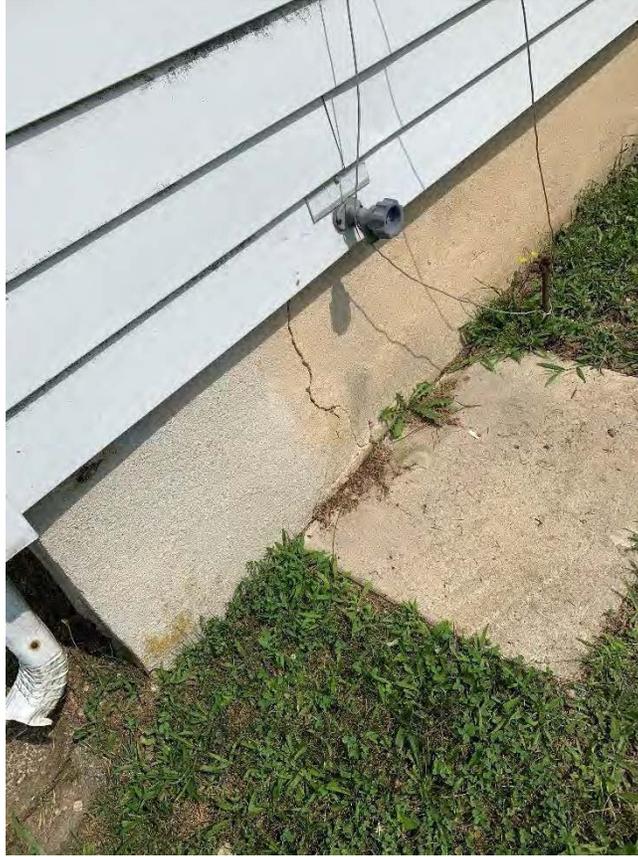
**Picture 1:**

1. Significant cracks in rubble stone foundation wall at rear exterior corner (See Picture 1).
2. Water infiltration in basement has eroded mortar in basement wall ( See Pictures 2, 29, 30, 31).

Significant crack in rubble stone foundation wall at rear exterior corner

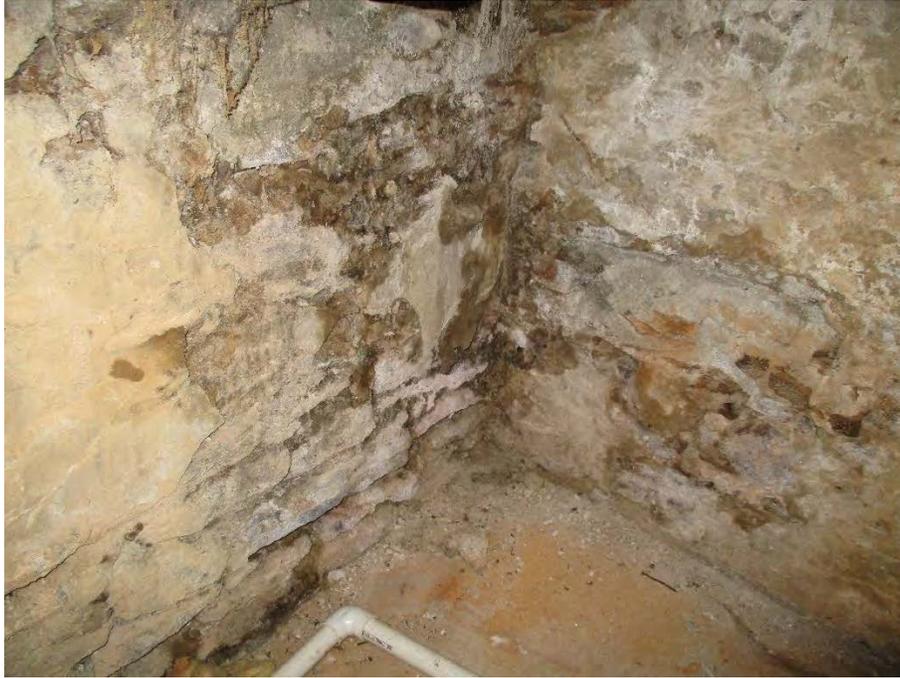
**Picture 2:**

Water infiltration in basement has eroded mortar in basement wall

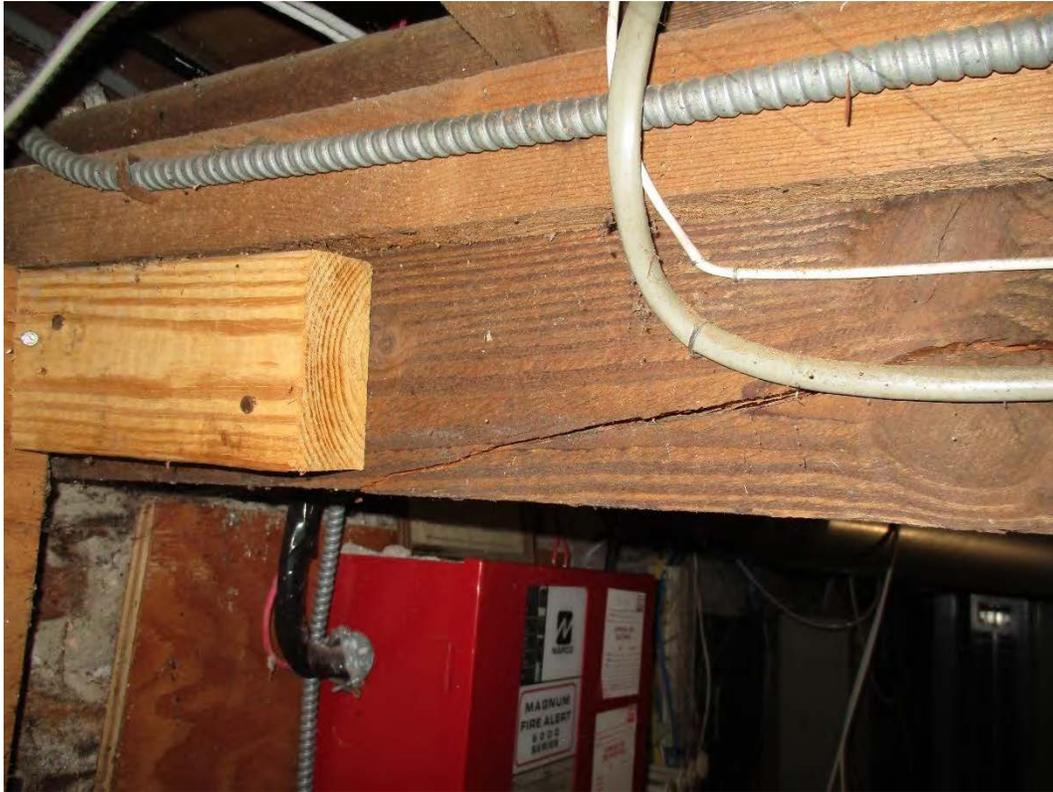
**Picture 3:**

3. Cracking in the existing CMU wall supporting the exterior concrete ramp ( See Picture 23).
4. Significant cracks in wood joist and girders supporting first floor (See Pictures 3, 4, 5, 24, 25, 26).

Significant cracks in wood beams supporting first floor

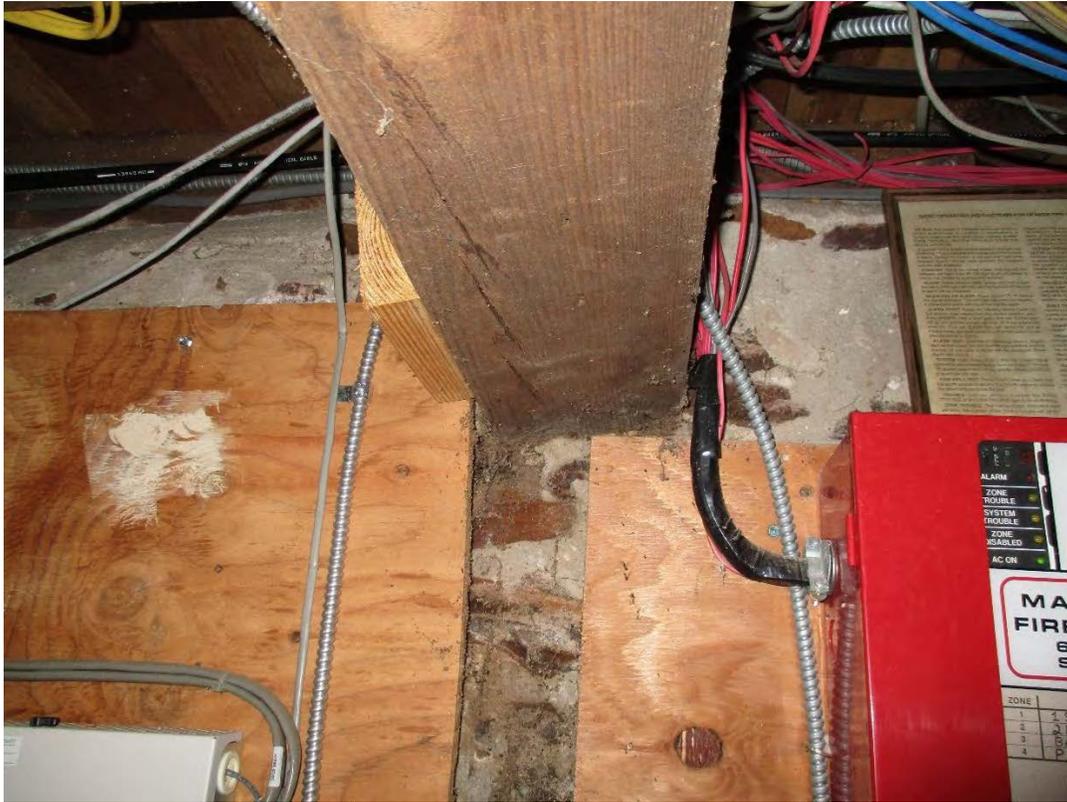
**Picture 4:**

Significant cracks in wood beams supporting first floor

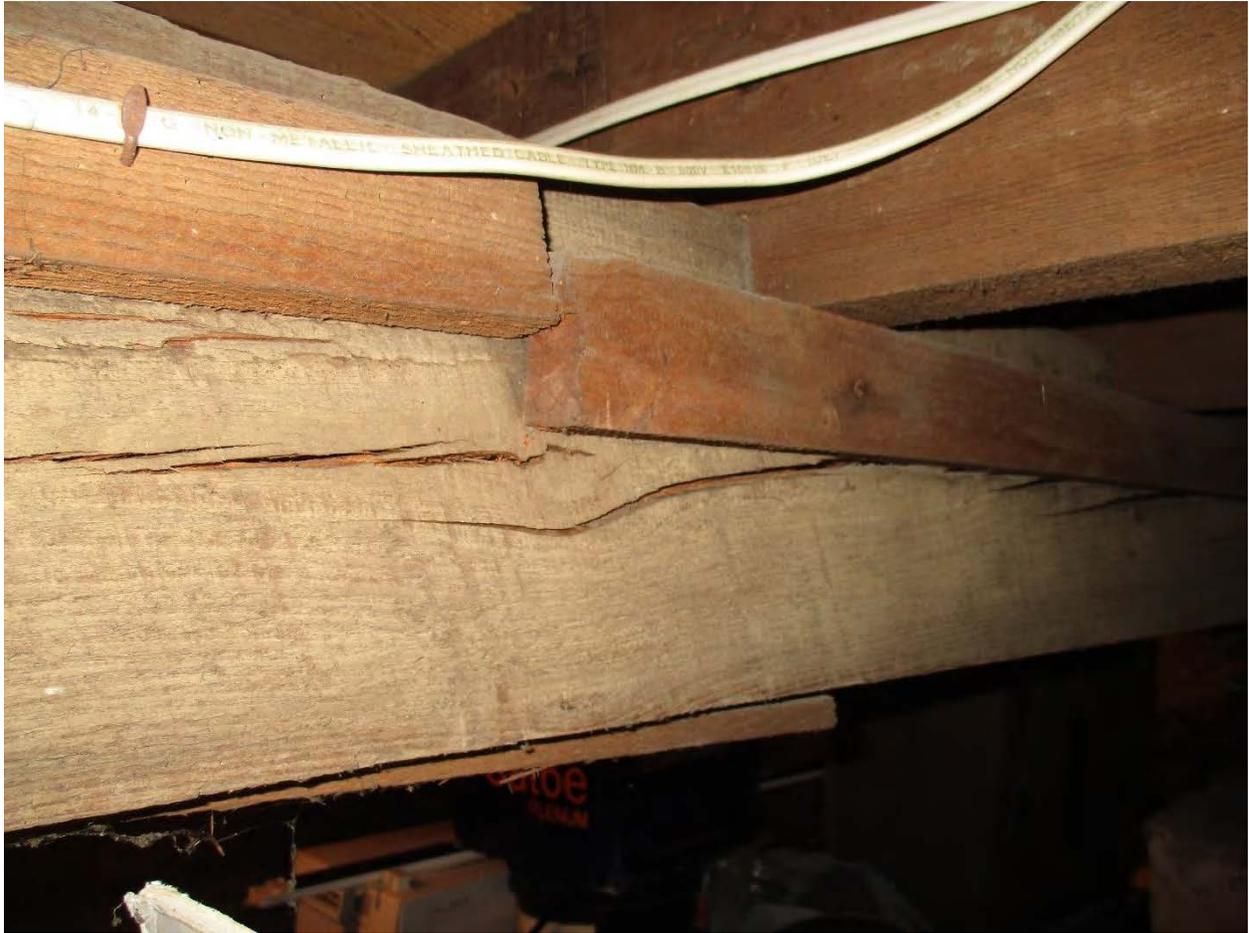
**Picture 5:**

Significant cracks in wood beams supporting first floor

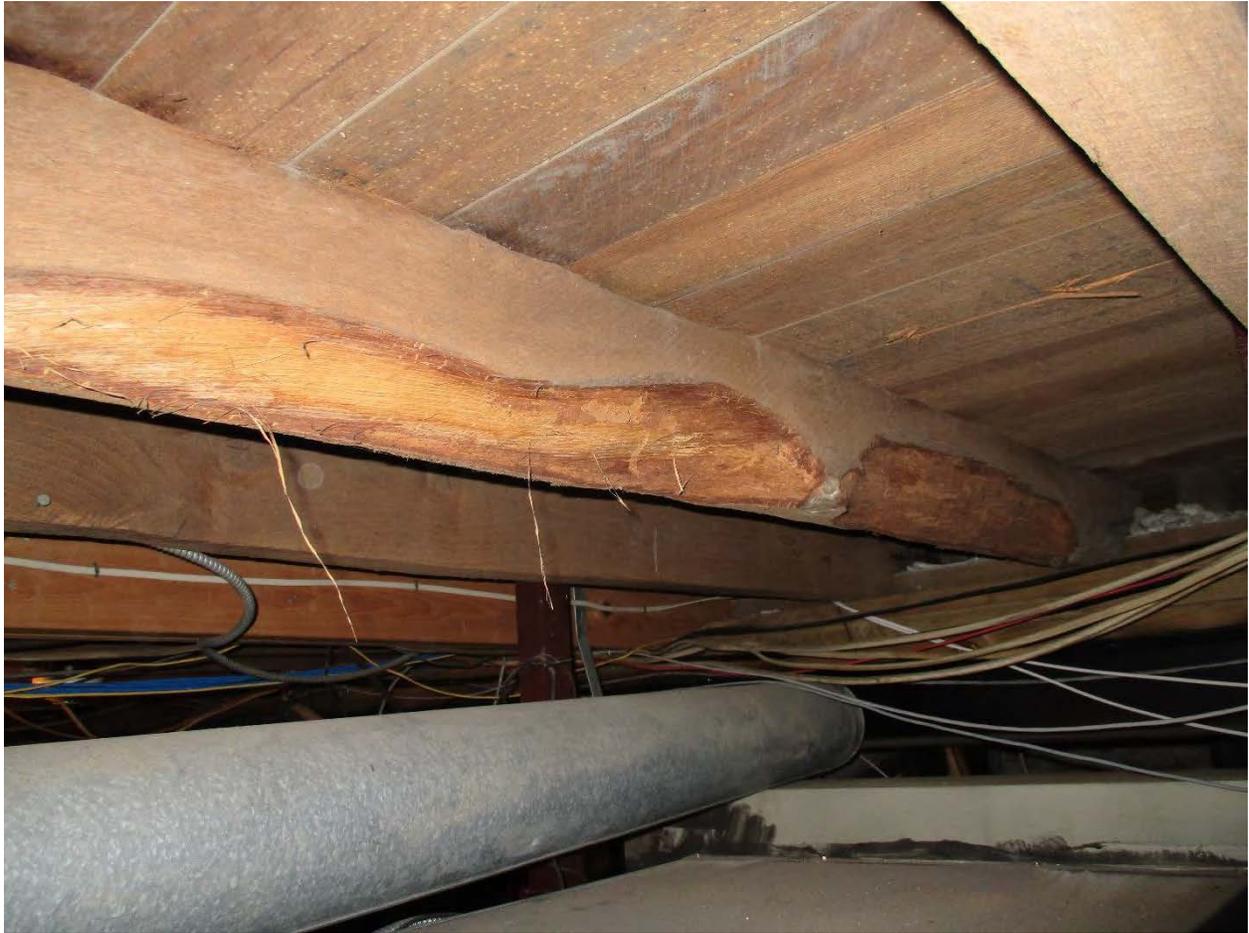
**Picture 6:**

5. Indications of previous termite infestation and deterioration at First Floor wood framing. (See Pictures 6, 21, 24, 27).
6. Deterioration of existing wood beams/joist bearing on rubble stone walls basement wall was observed. (See Picture 21).

Indications of previous termite infestation

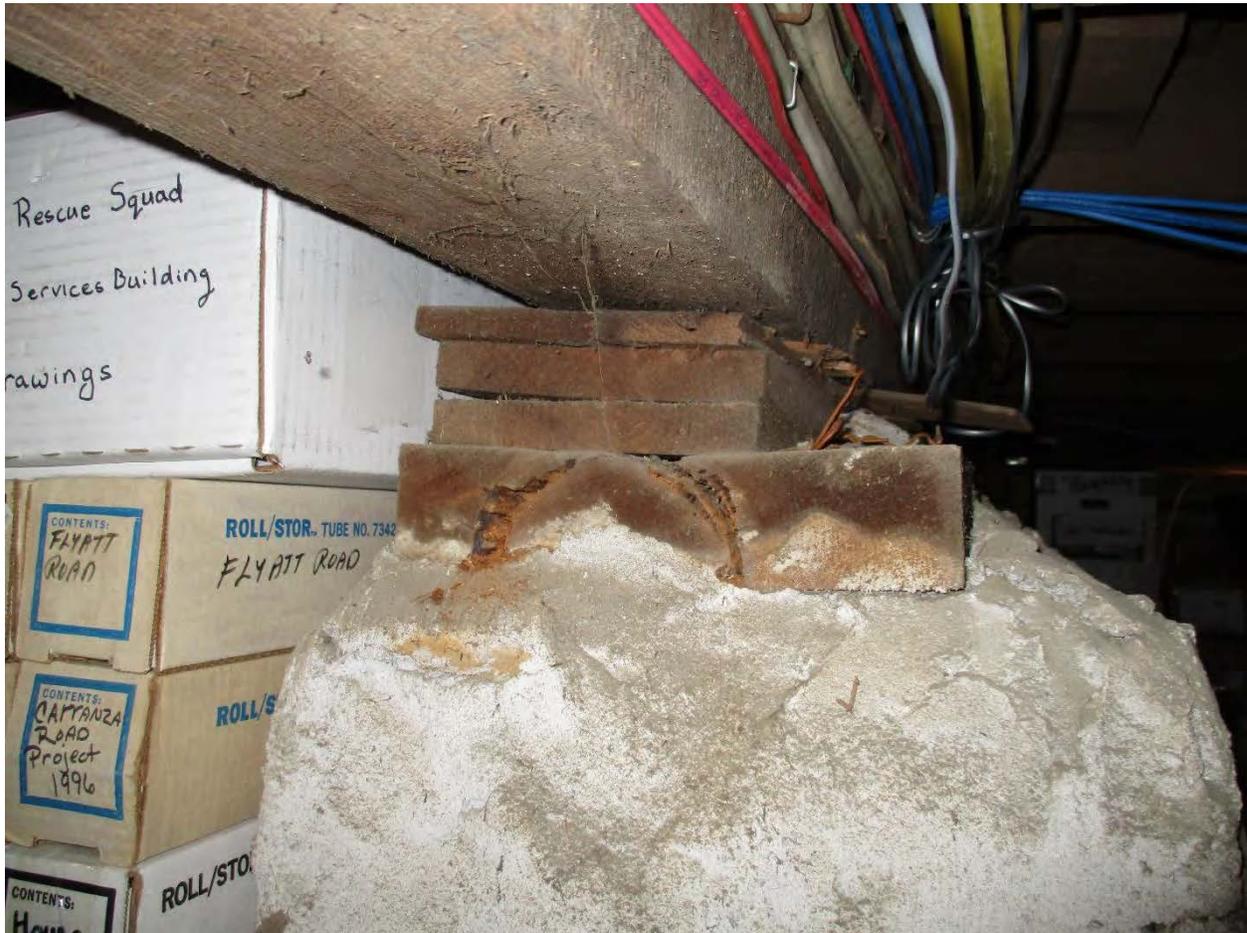
**Picture 7:**

7. Wood shims have not been installed properly causing overstress in first floor wood joist bearing. (See Picture 7).
8. Wood joists have deficient connections (See Pictures 13, 17, 18, 20, 26).

Wood shims not on installed properly causing overstress in first floor wood joist bearing

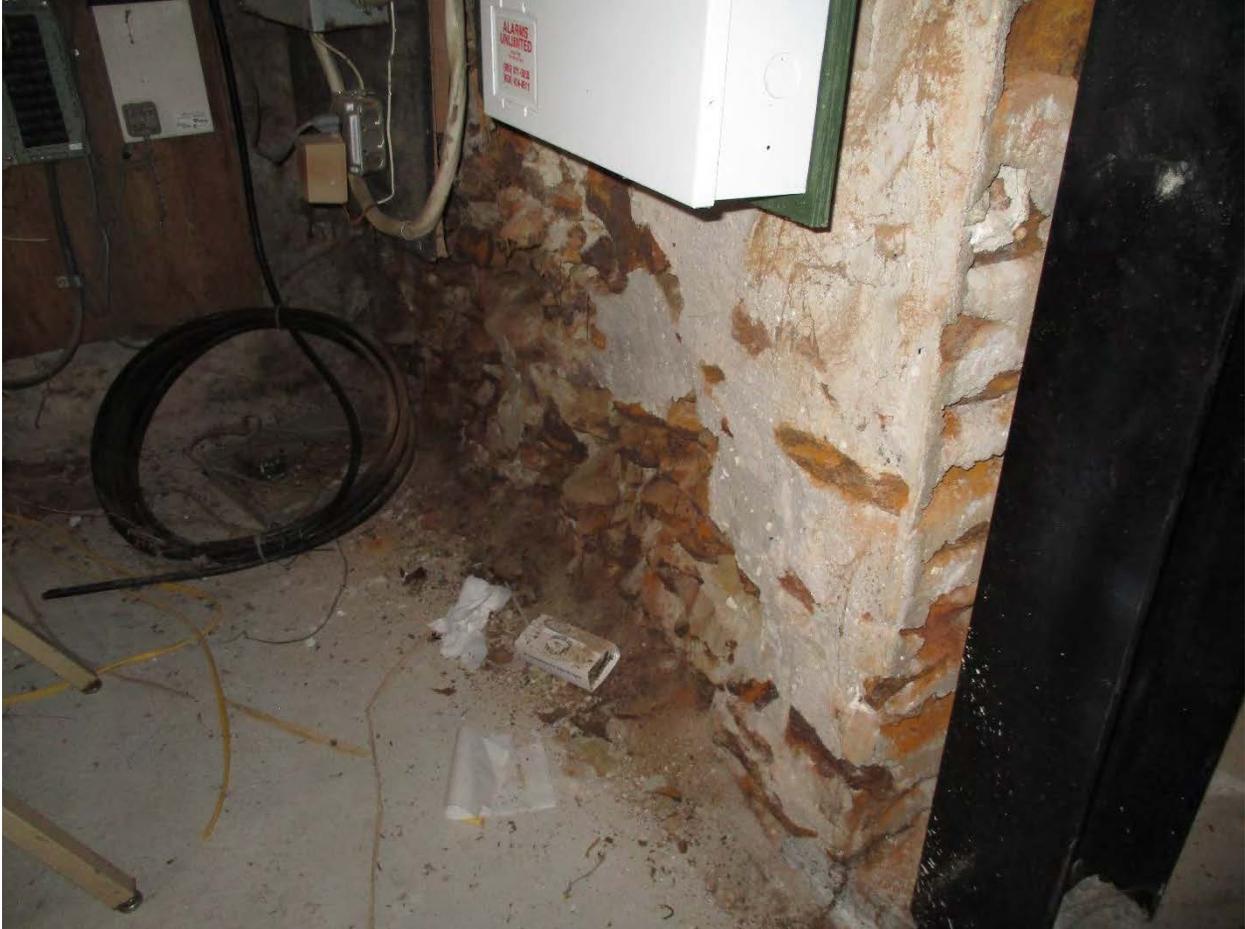
**Picture 8:**

9. Wet wall condition at electrical panel in basement. (See Picture 8).
10. New steel columns added to support first floor beams bears on basement slab without a footing. (See Picture 9).

Wet wall condition at electrical panel in basement

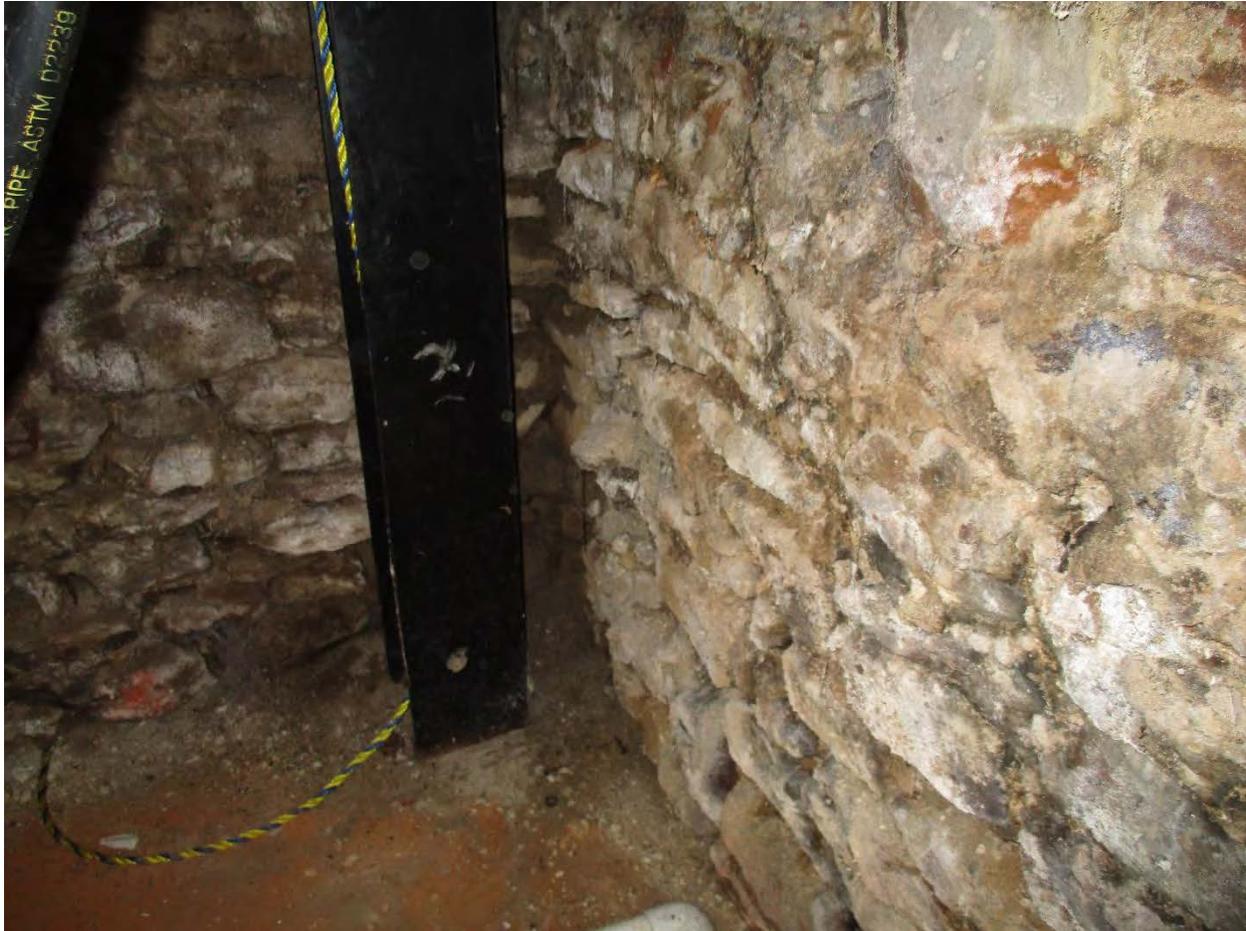
**Picture 9:**

New steel columns added to support first floor beams bears on basement slab with no footing

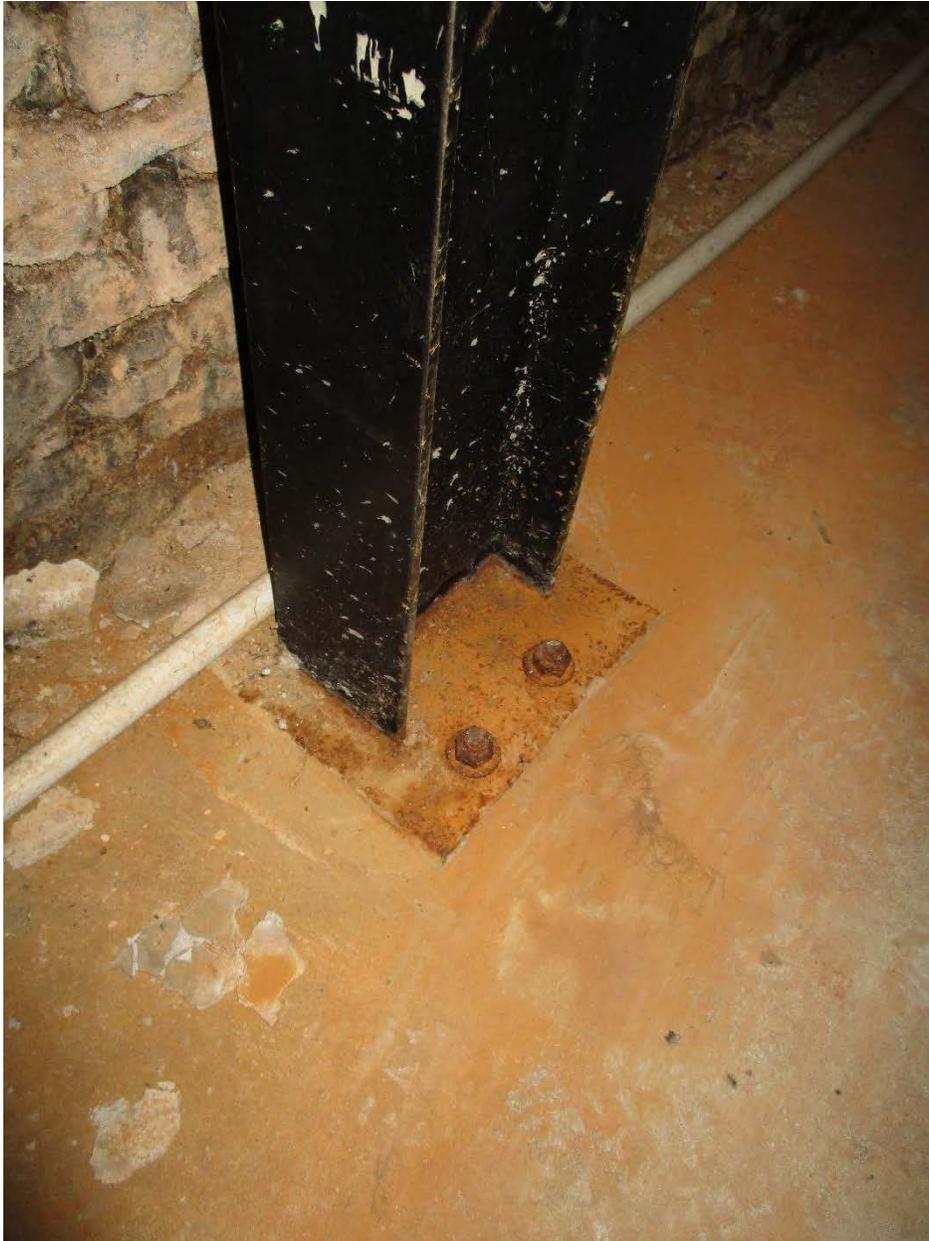
**Picture 10:**

New steel columns supporting first floor beams appears to bear on slab without footing

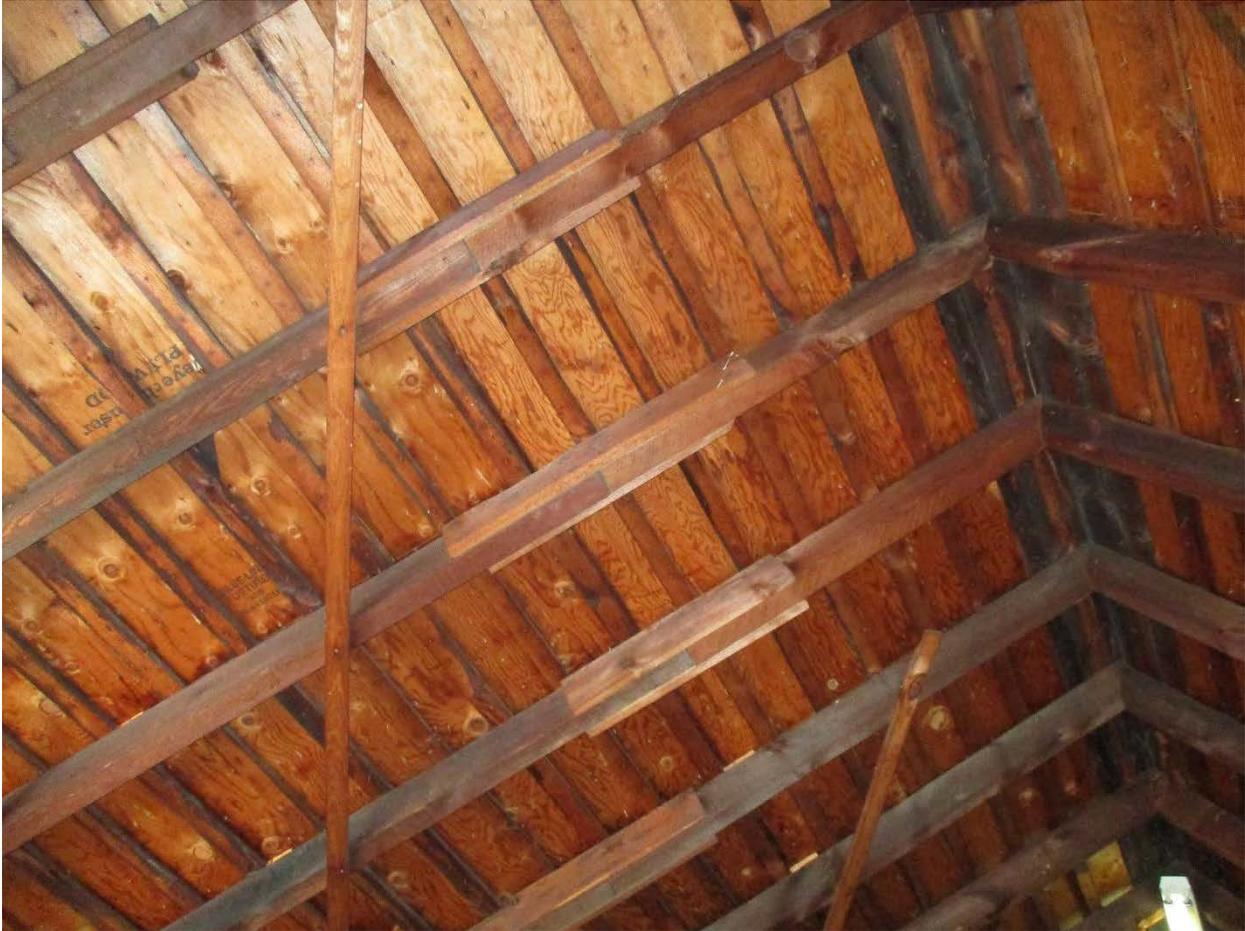
**Picture 11:**

No plate connection for roof rafters at roof

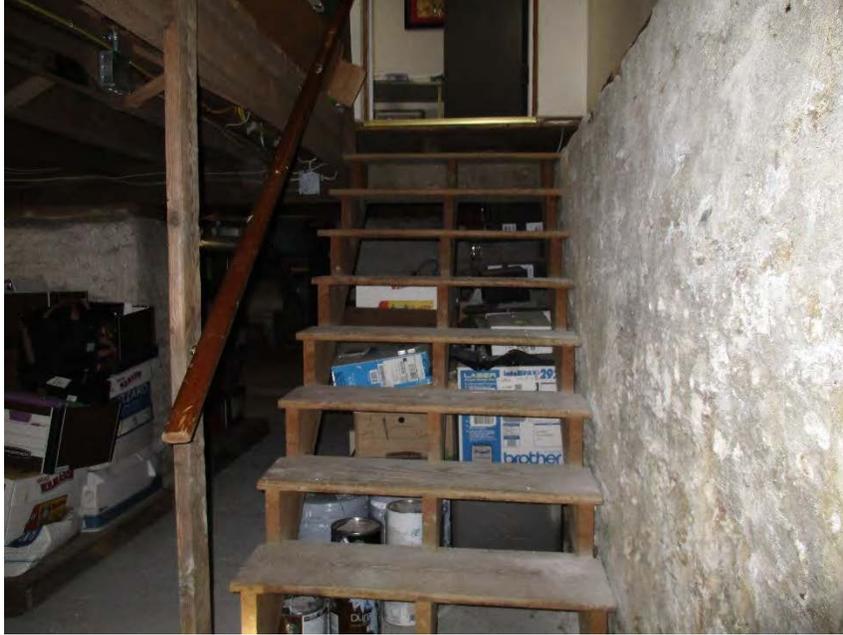
**Picture 12:**

Wood stair to basement needs to be reinforced to support required loading

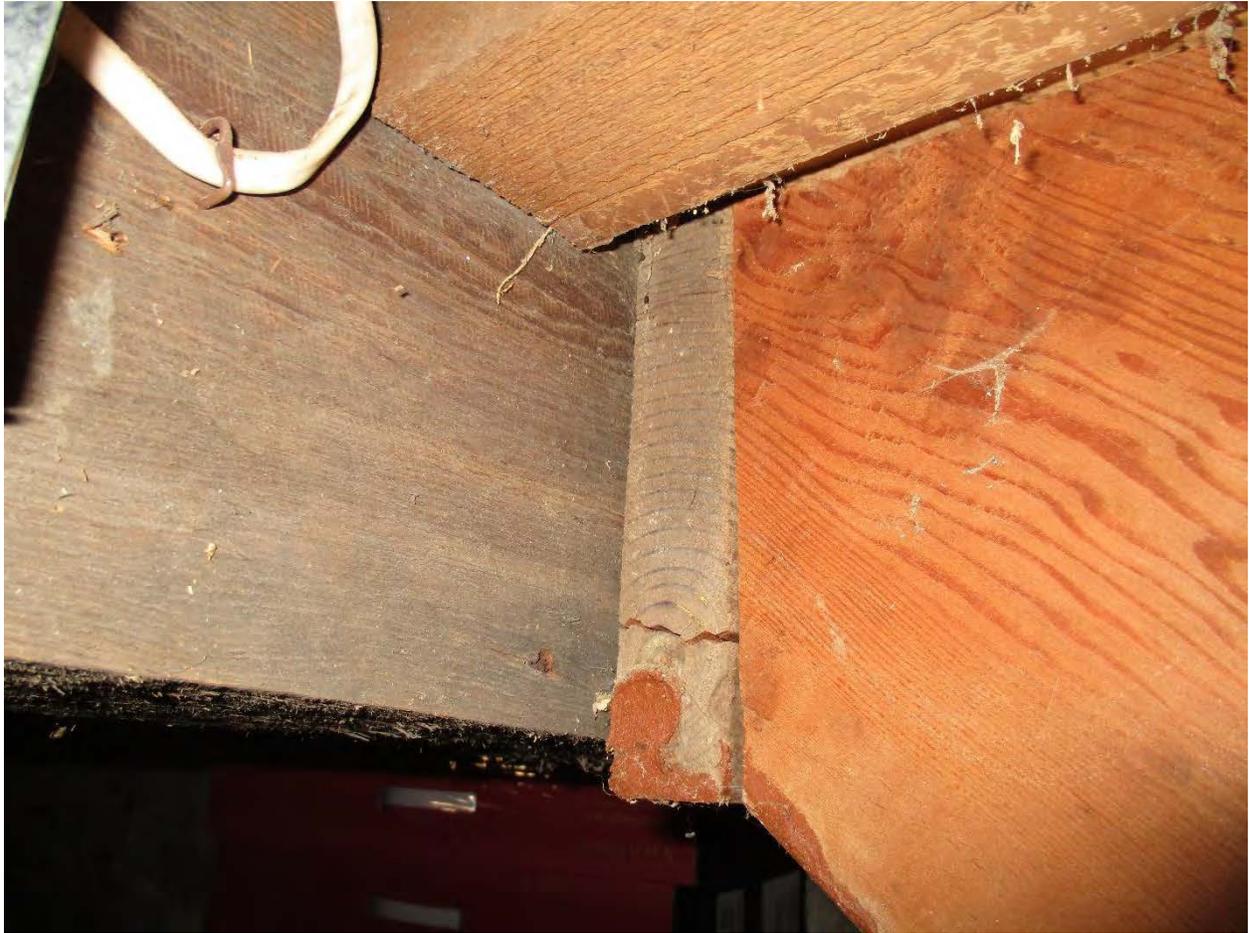
**Picture 13:**

Deficient Framing at Basement Stair connections

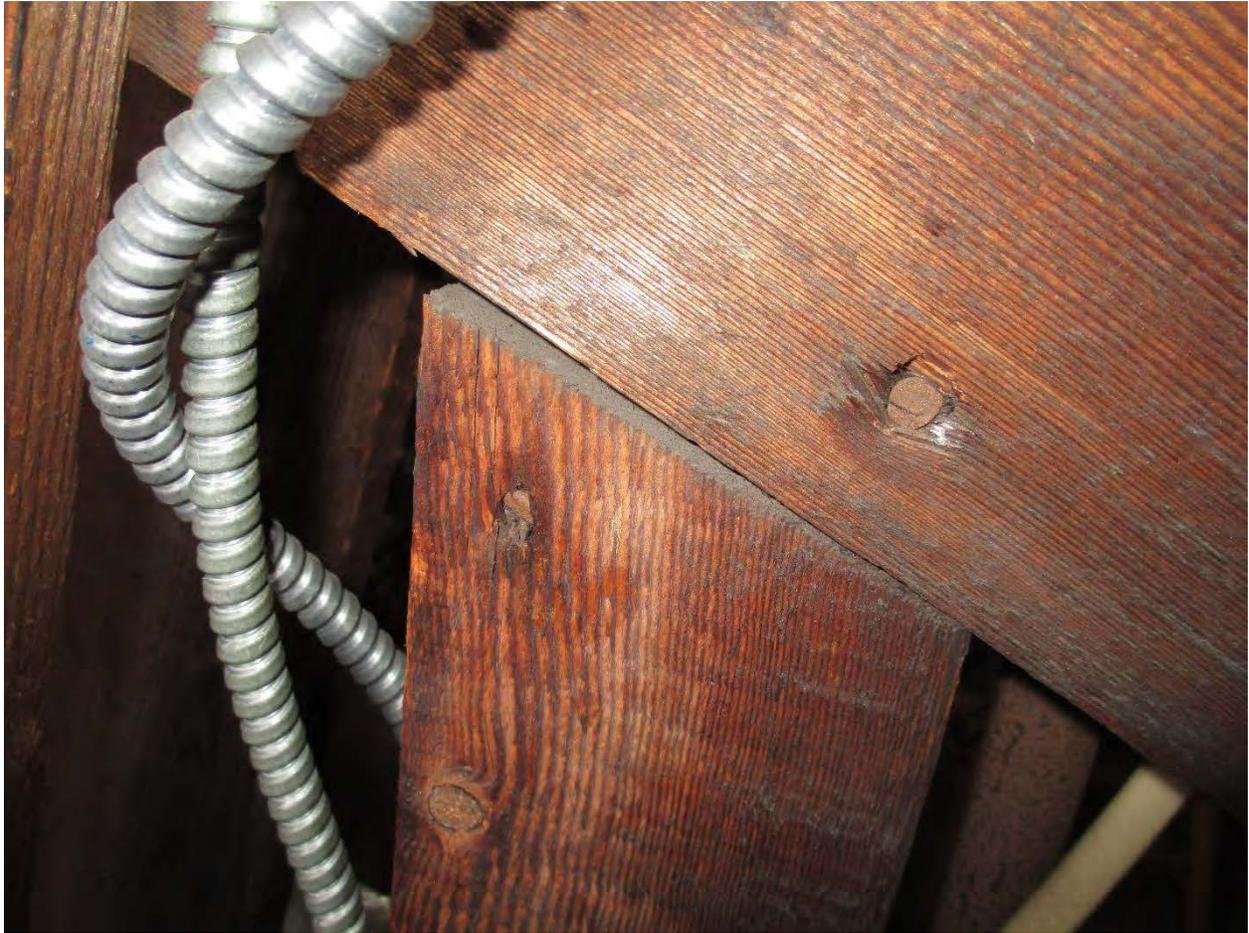
**Picture 14:**

Heavy Timber truss above second floor ceiling with deficient connections

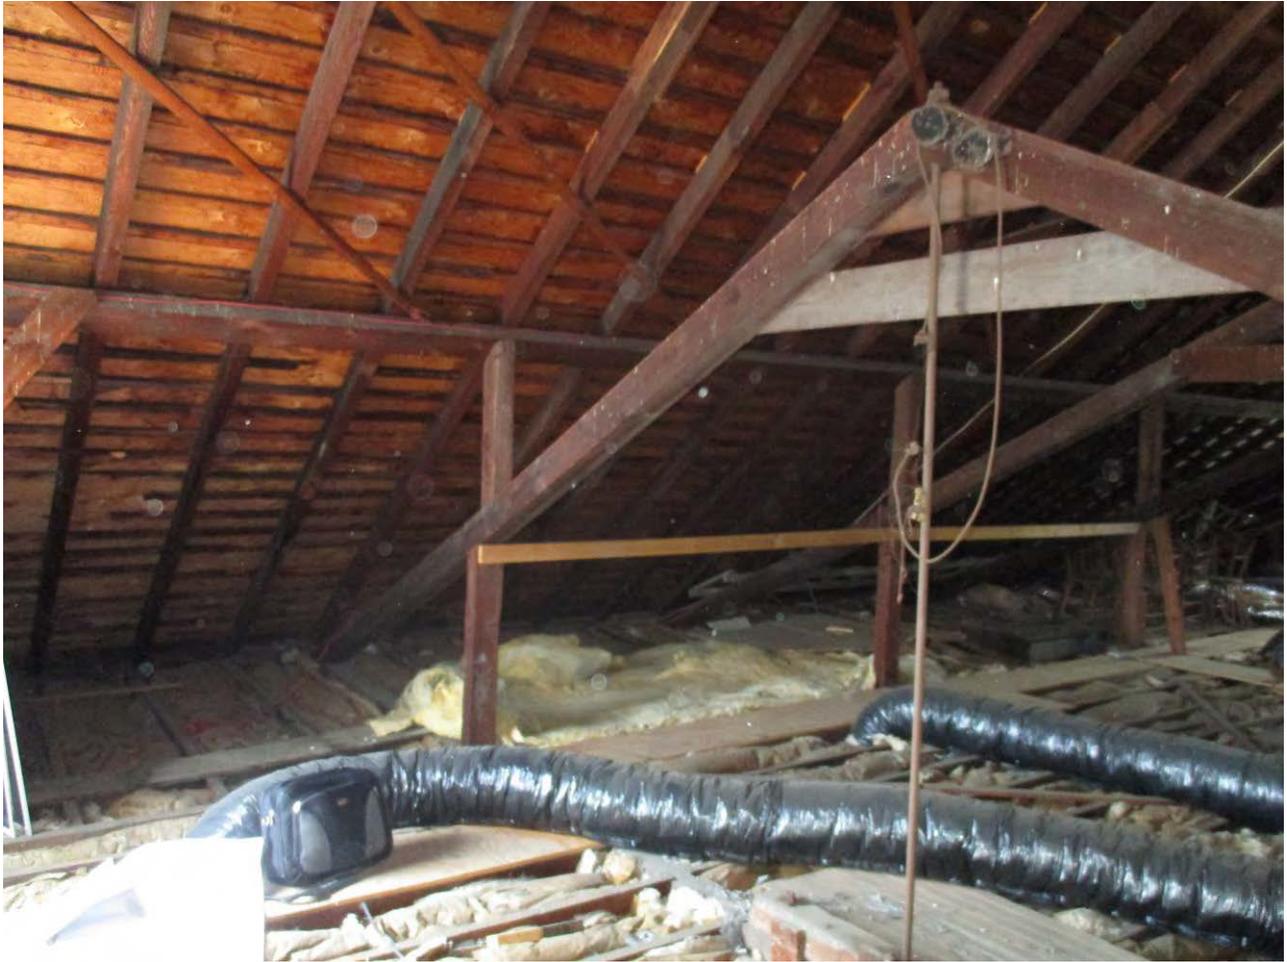
**Picture 15:**

Roof Structure with deficient connections

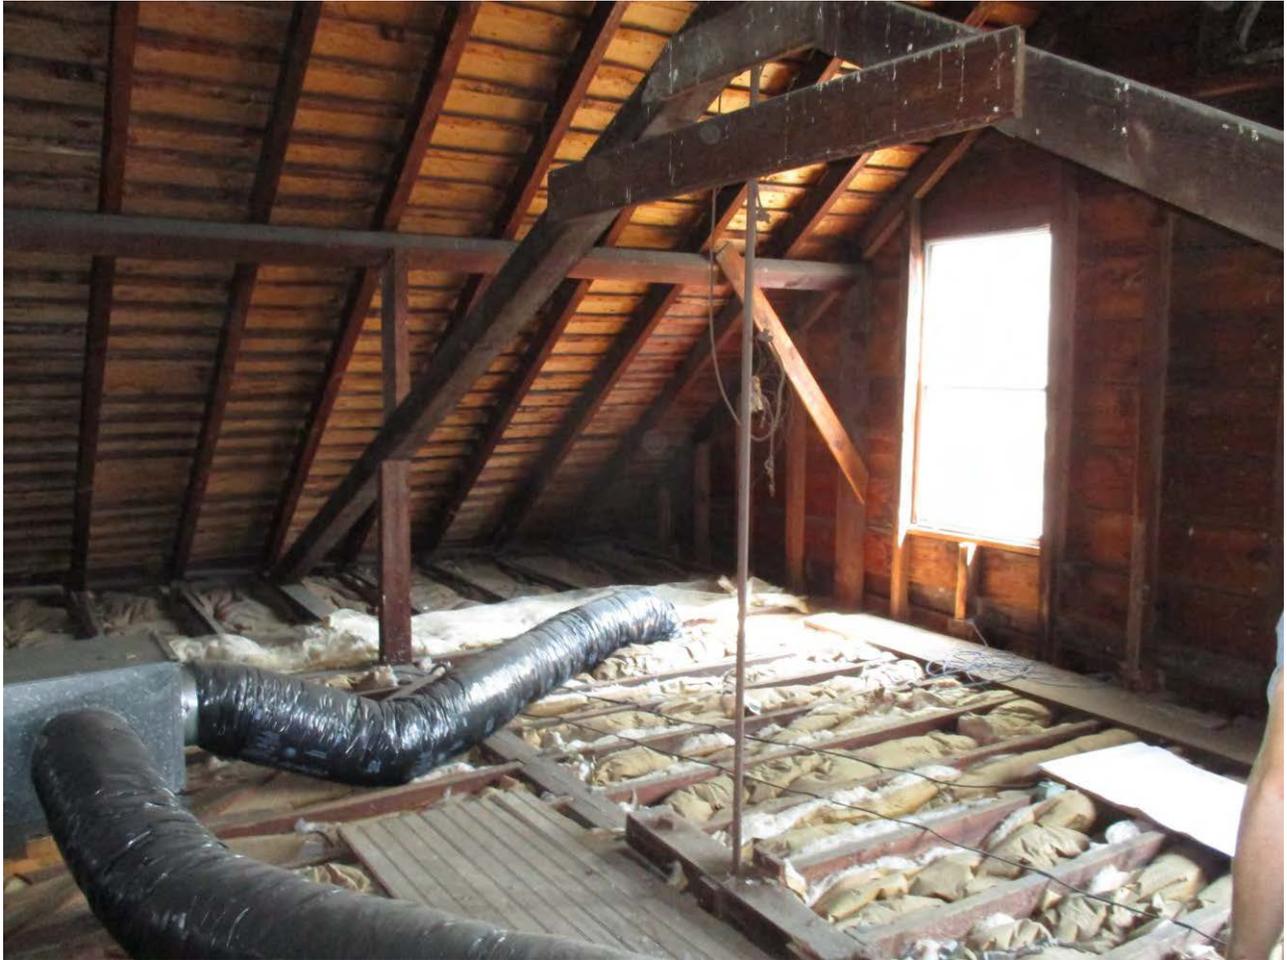
**Picture 16:**

Heavy Timber Wood Truss without bracing and deficient connections

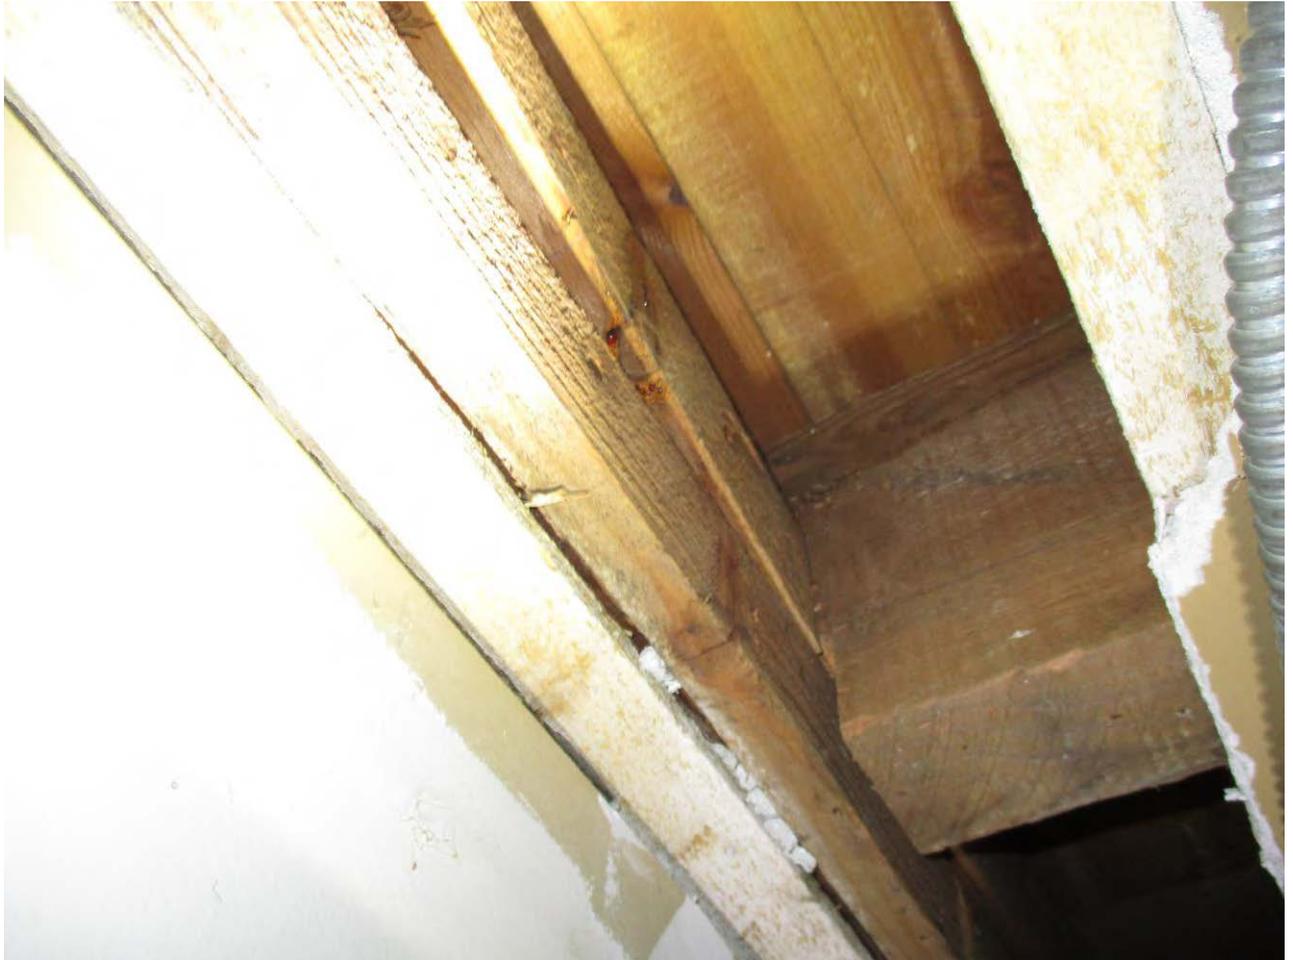
**Picture 17:**

Second Floor joist with deficient connections and cracking
