# FACILITY ASSESSMENT

## TABERNACLE TOWN HALL

**TOWNSHIP OF TABERNACLE**  
**163 CARRANZA ROAD, TABERNACLE, NEW JERSEY 08088**

**RYEBREAD PROJECT NO. 5665B**

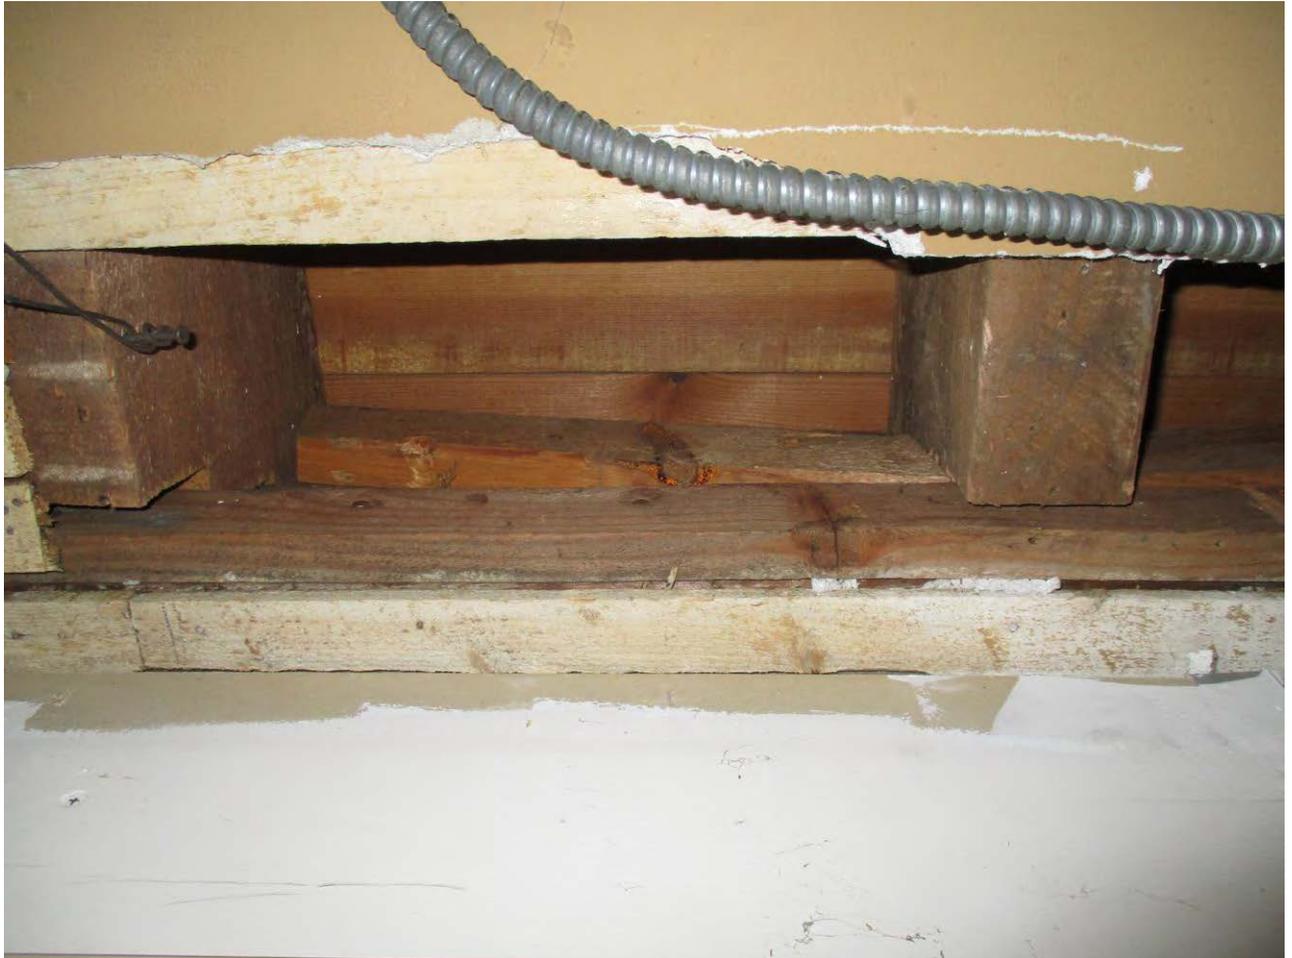
**Picture 18:**

Second Floor joist with deficient connections

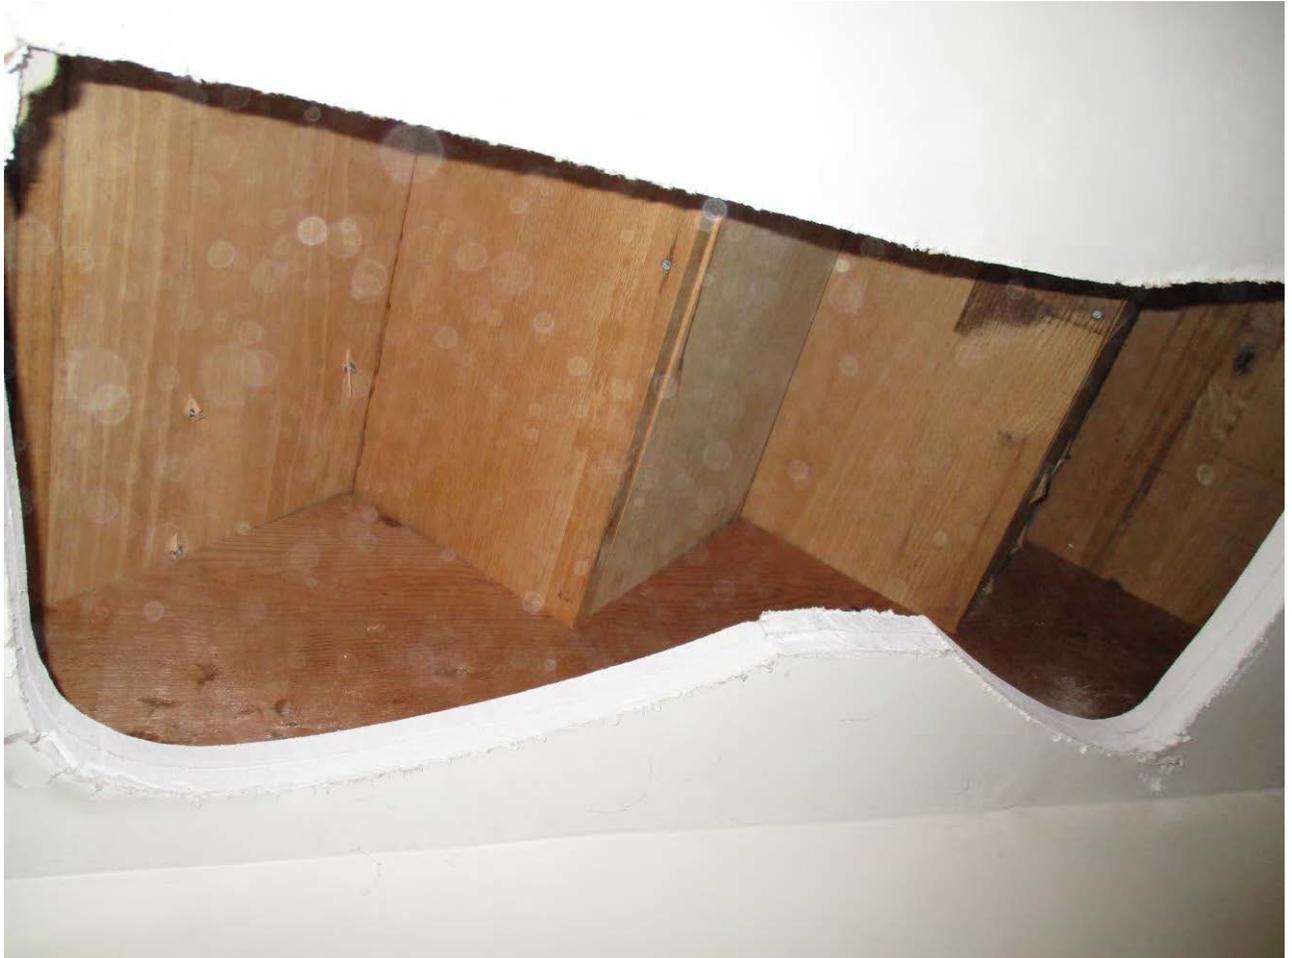
**Picture 19:**

Second Floor stair with notched stair stringer

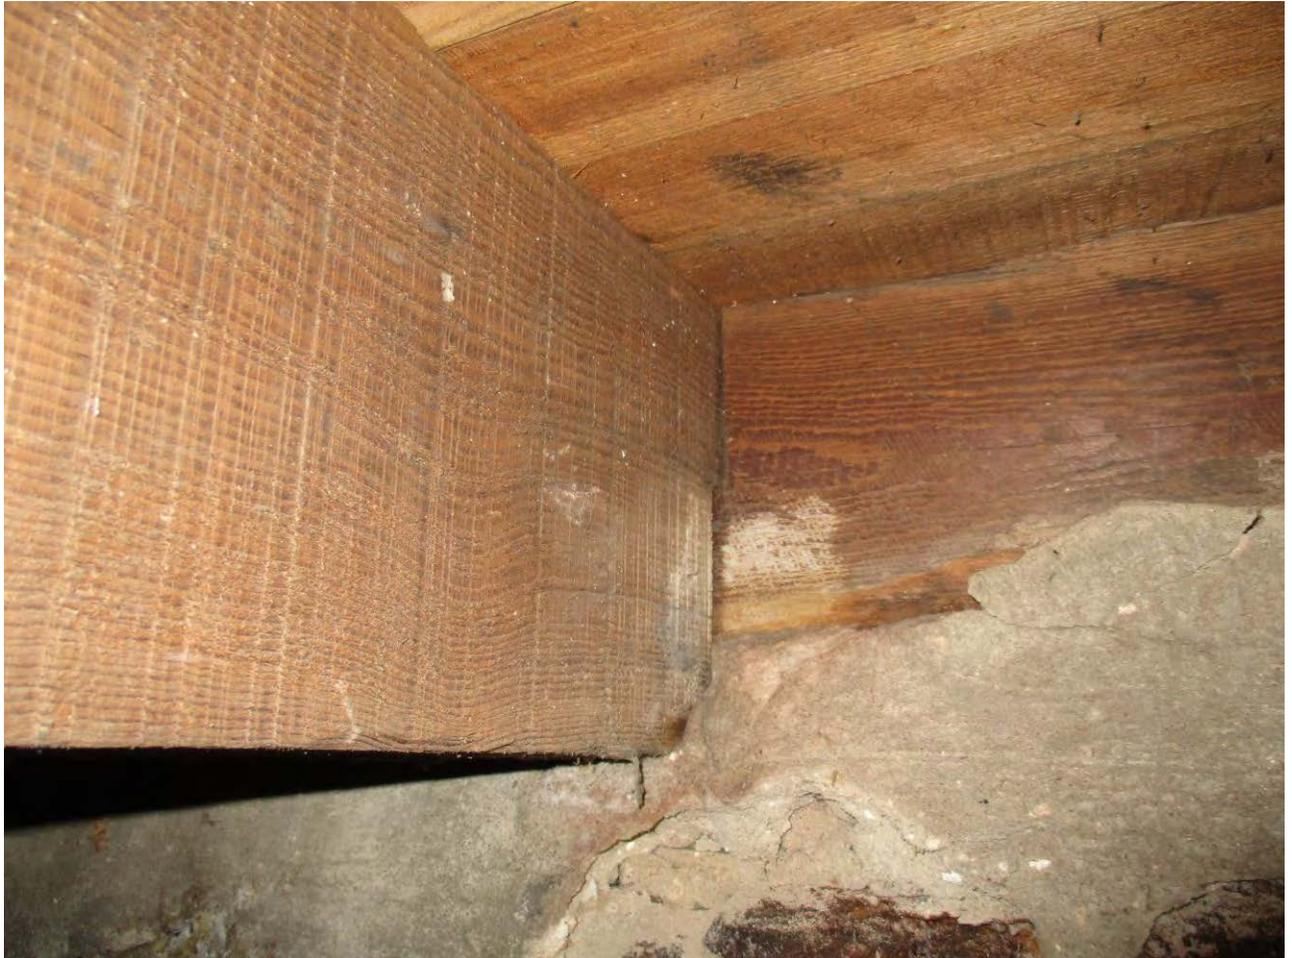
**Picture 20:**

First Floor joist with deficient connections

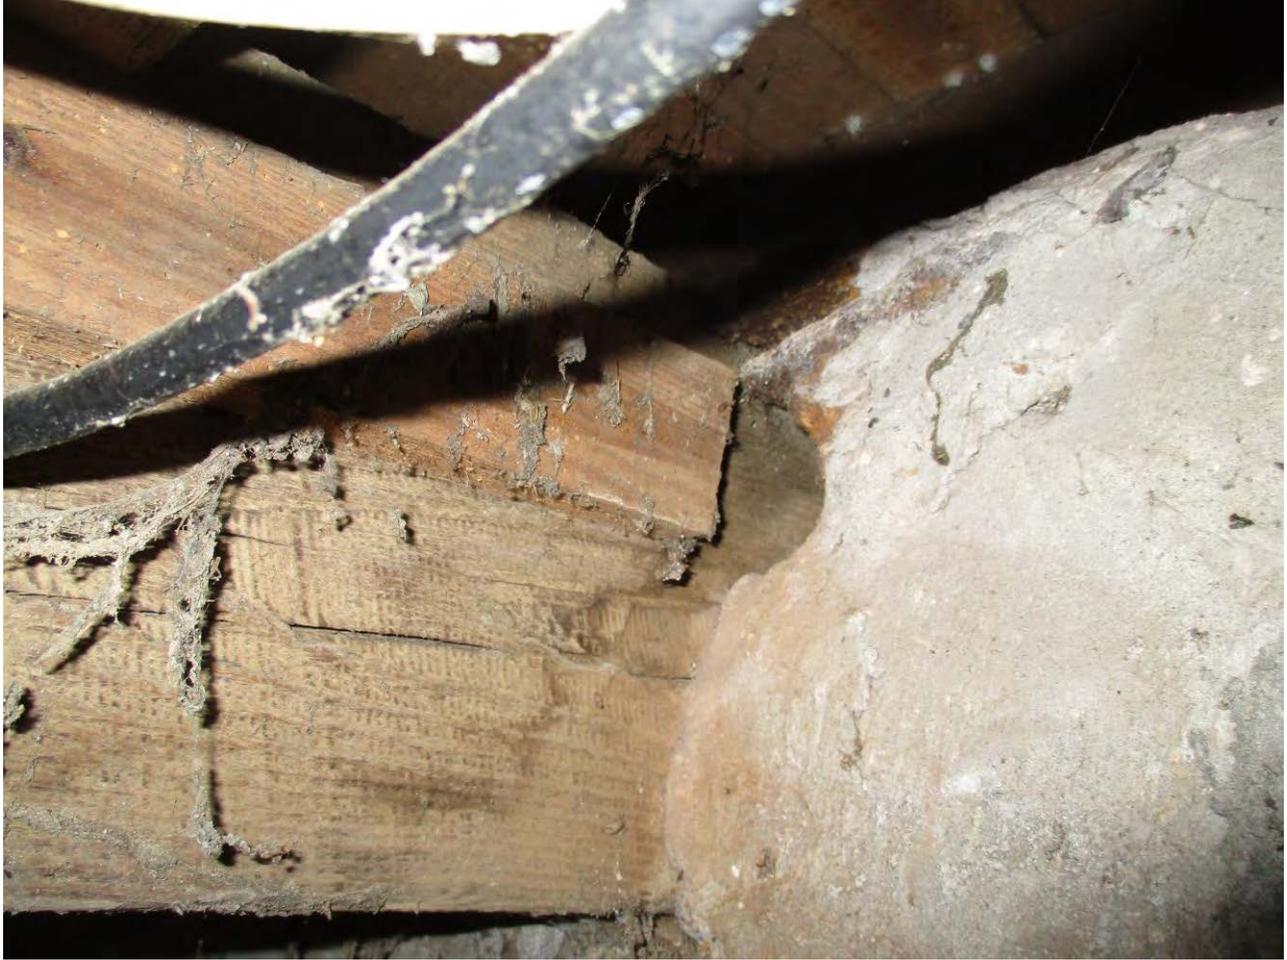
**Picture 21:**

First Floor joist with deterioration at bearing condition

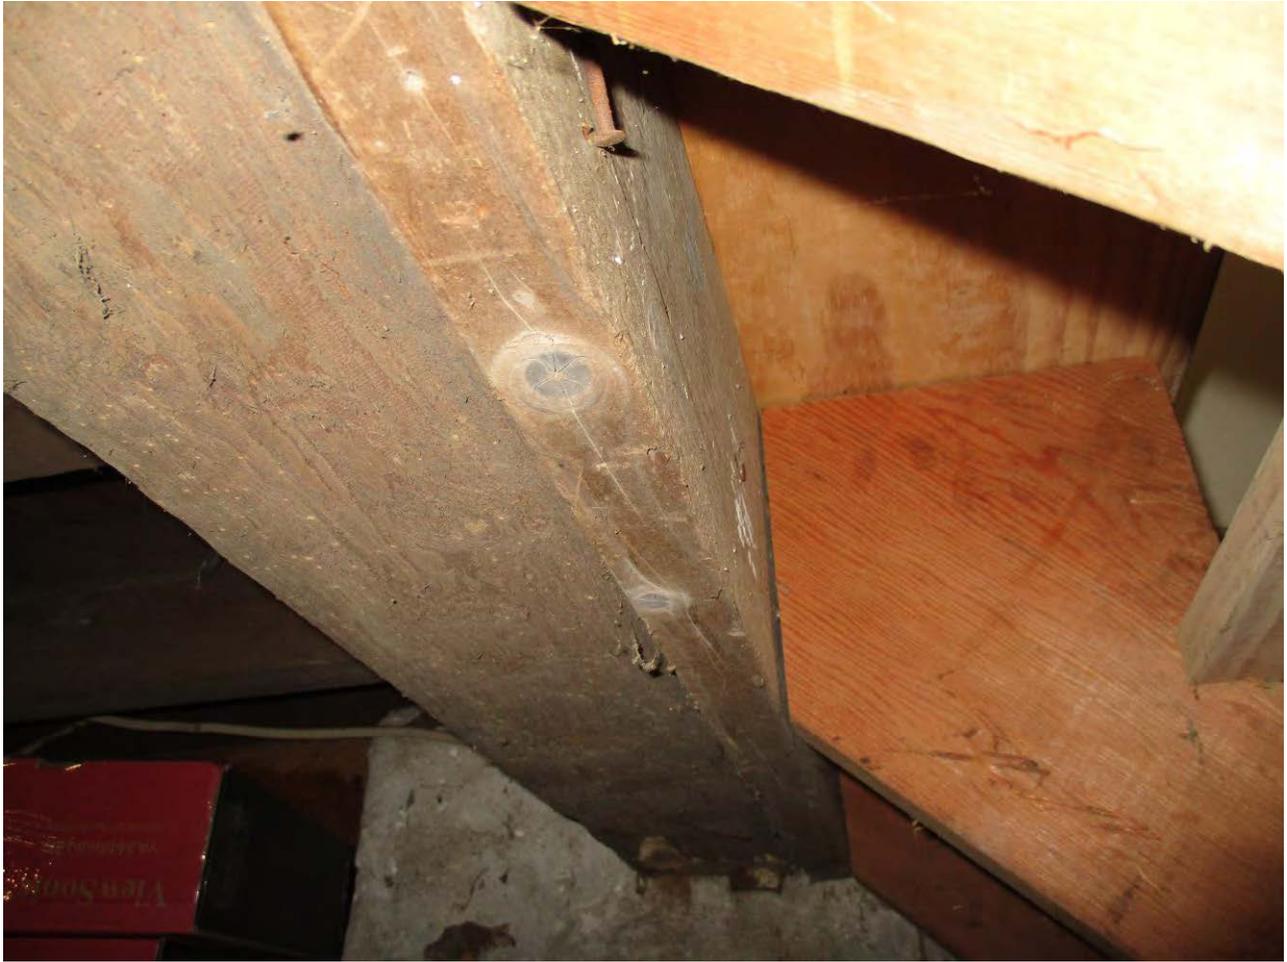
**Picture 22:**

First Floor Stair to Basement with deficient connection

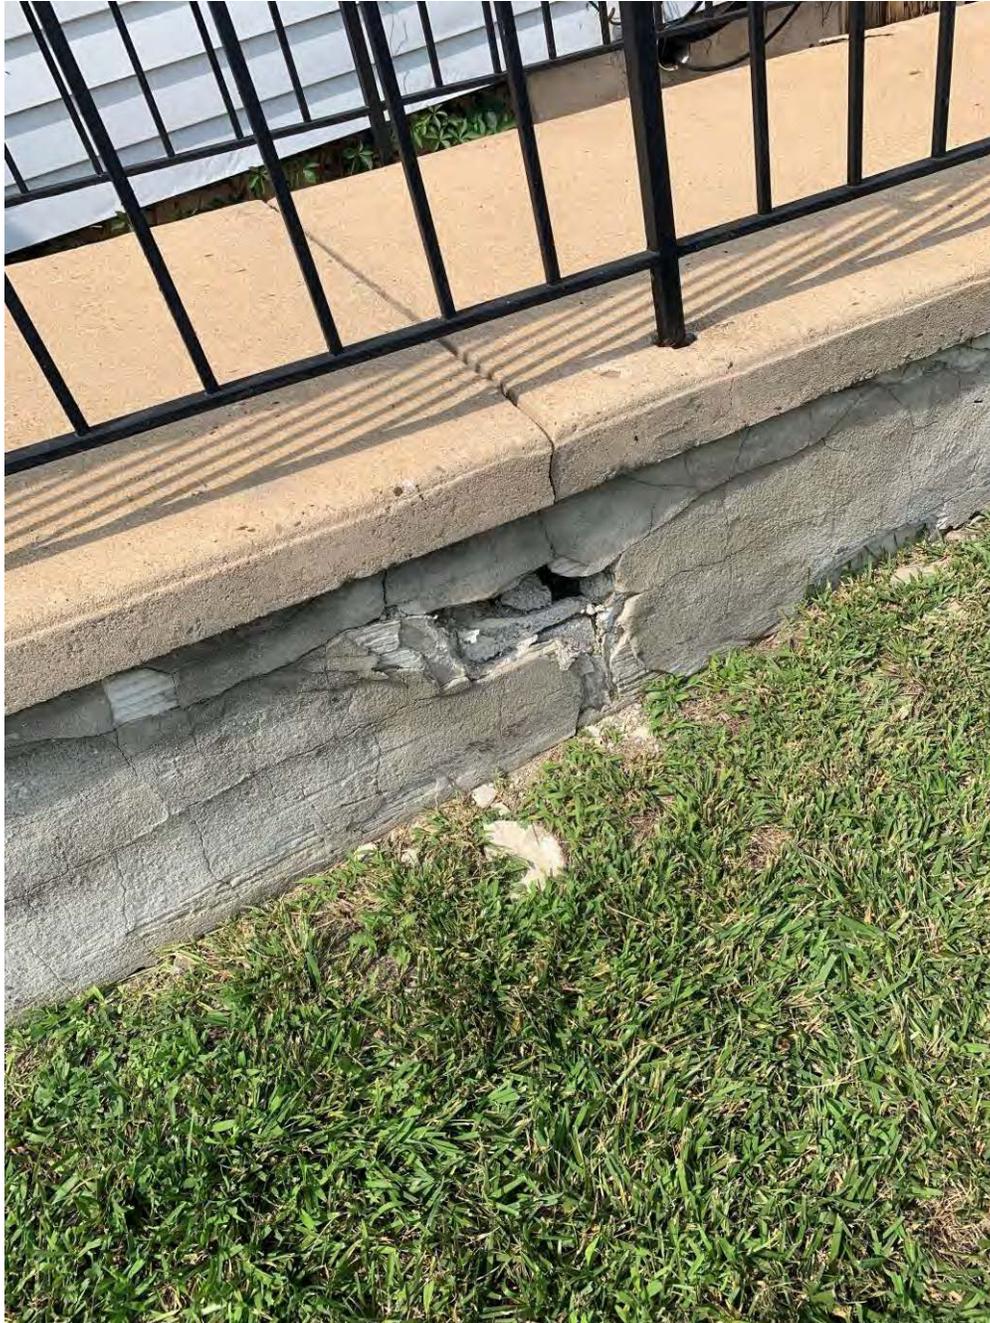
**Picture 23:**

Handicap Ramp Foundation Deterioration

2.2 The existing foundation wall for the exterior concrete ramp has deteriorated. Repair or replacement of the ramp is required.

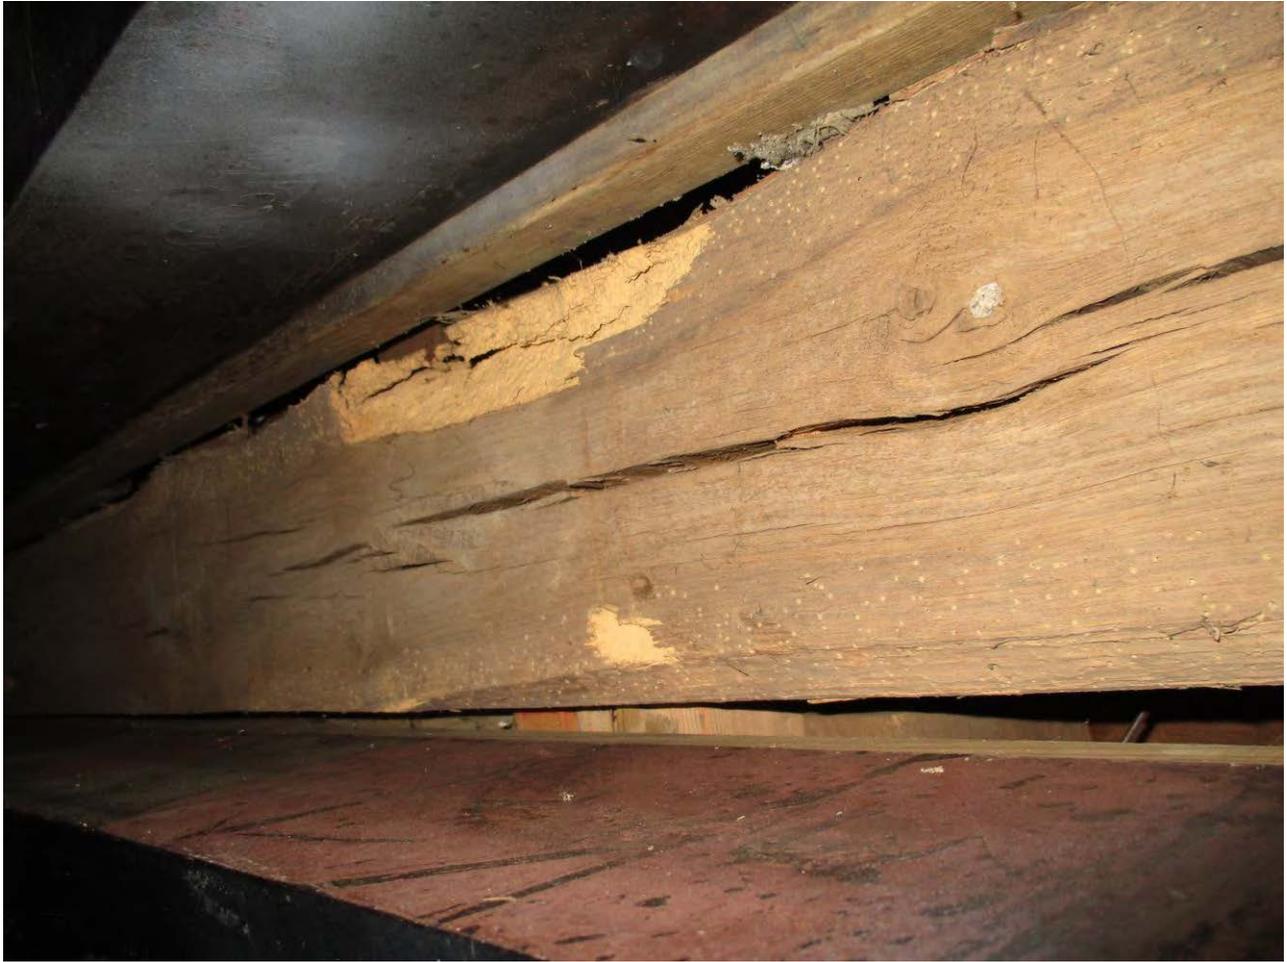
**Picture 24:**

First Floor Framing deterioration

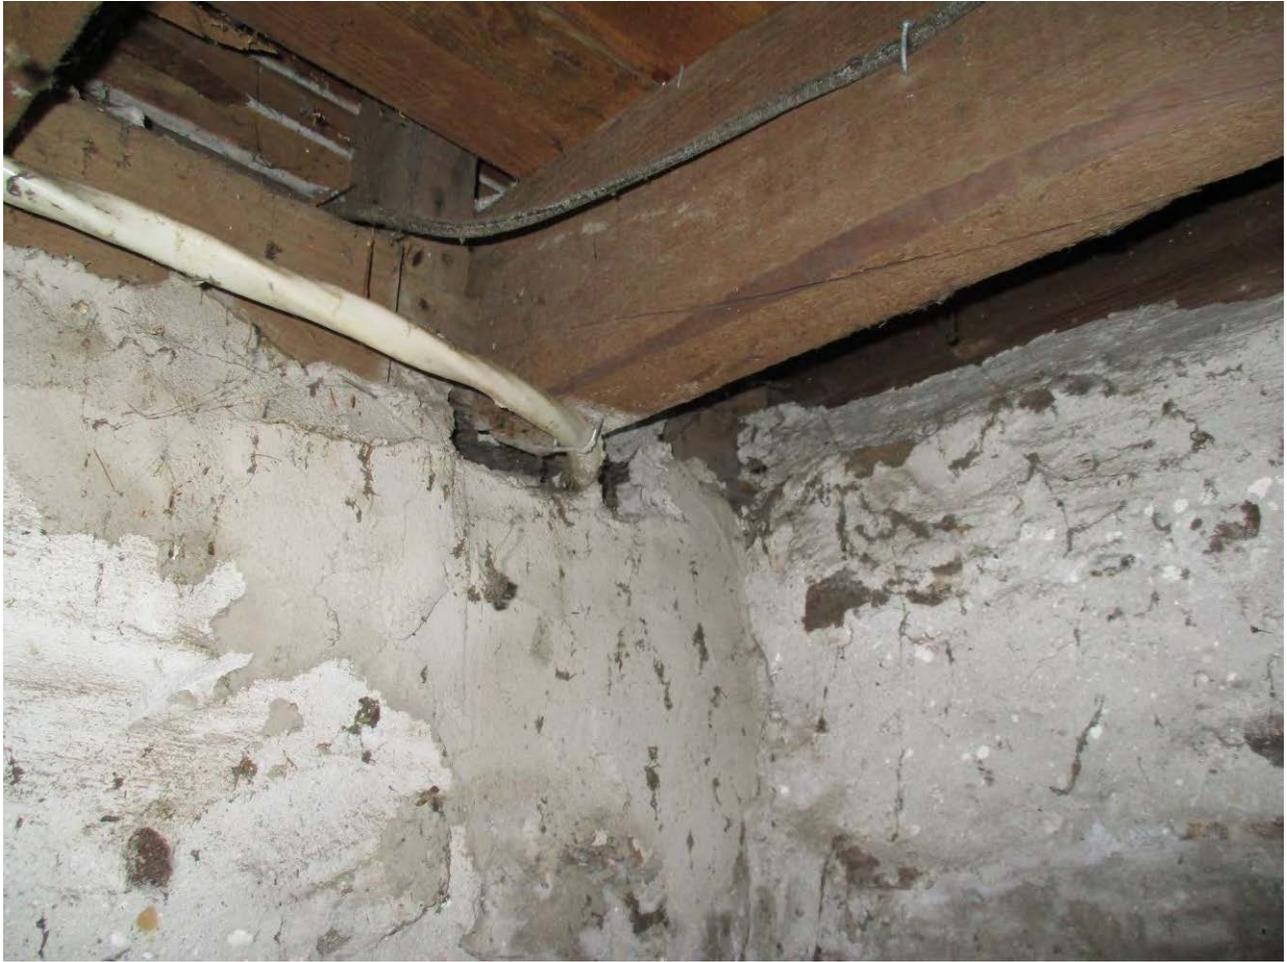
**Picture 25:**

First Floor Framing cracking

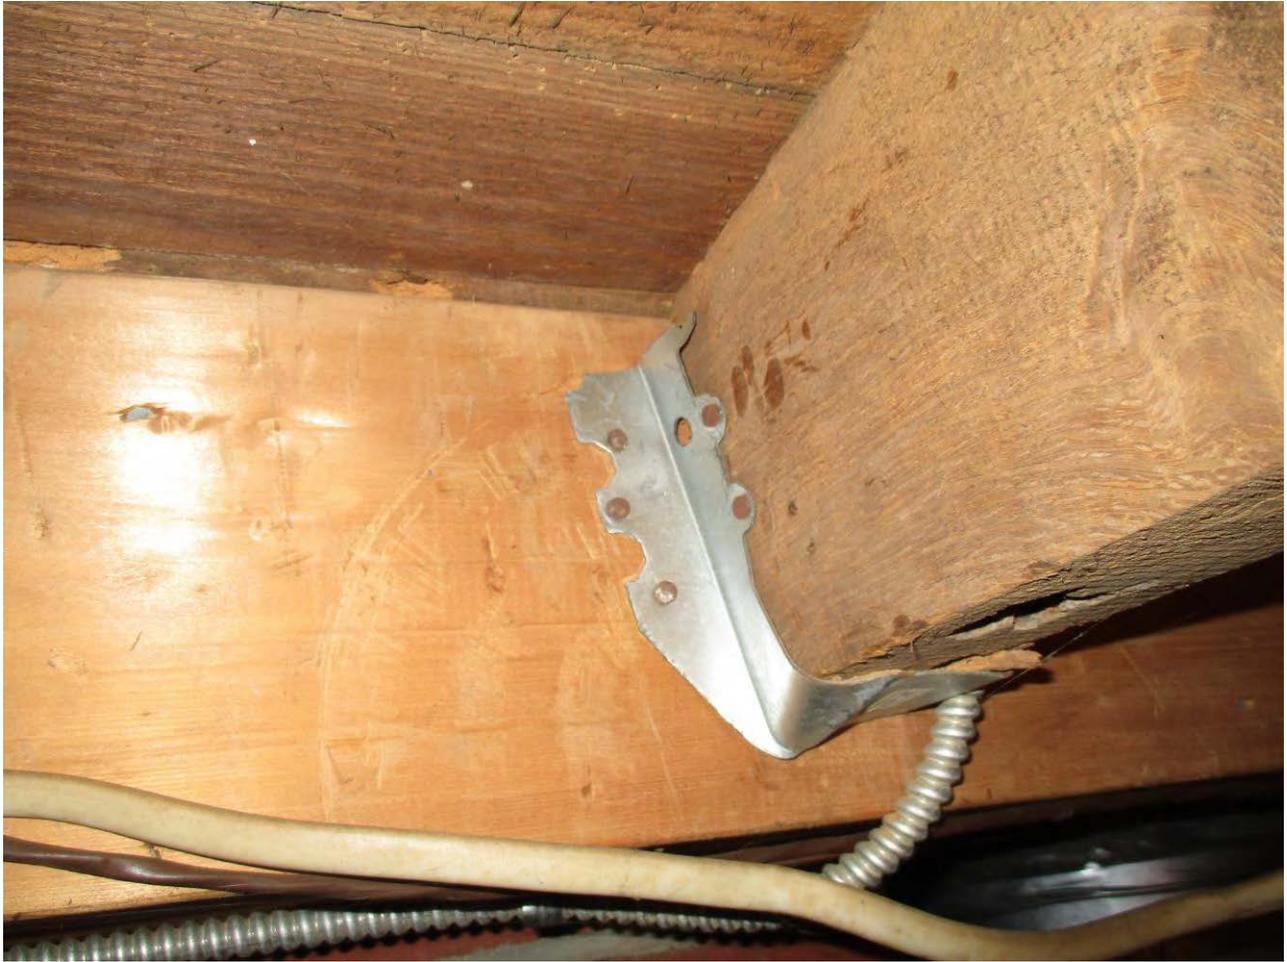
**Picture 26:**

First Floor Framing cracking

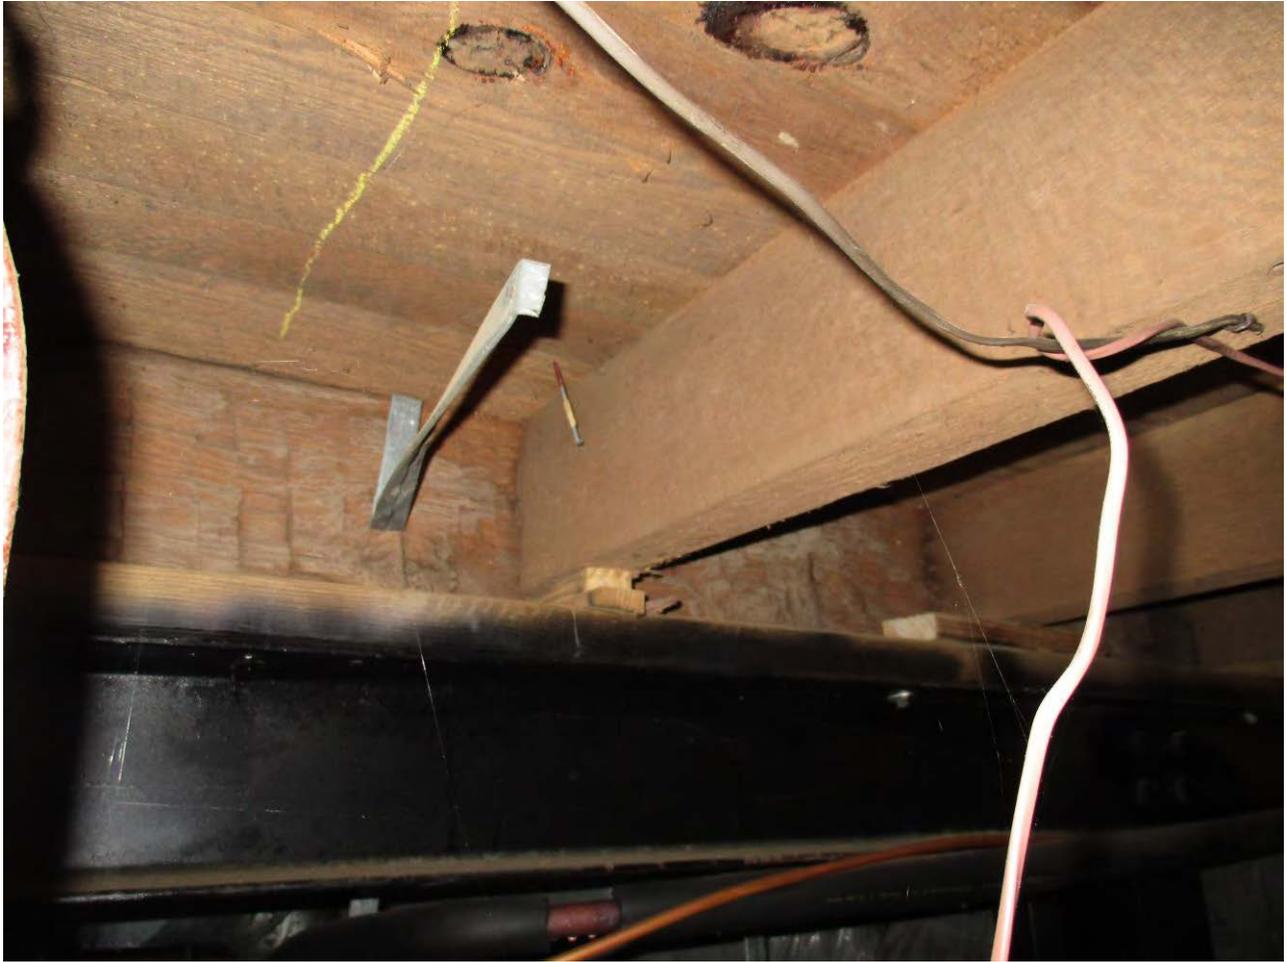
**Picture 27:**

First Floor Framing connection deficiency

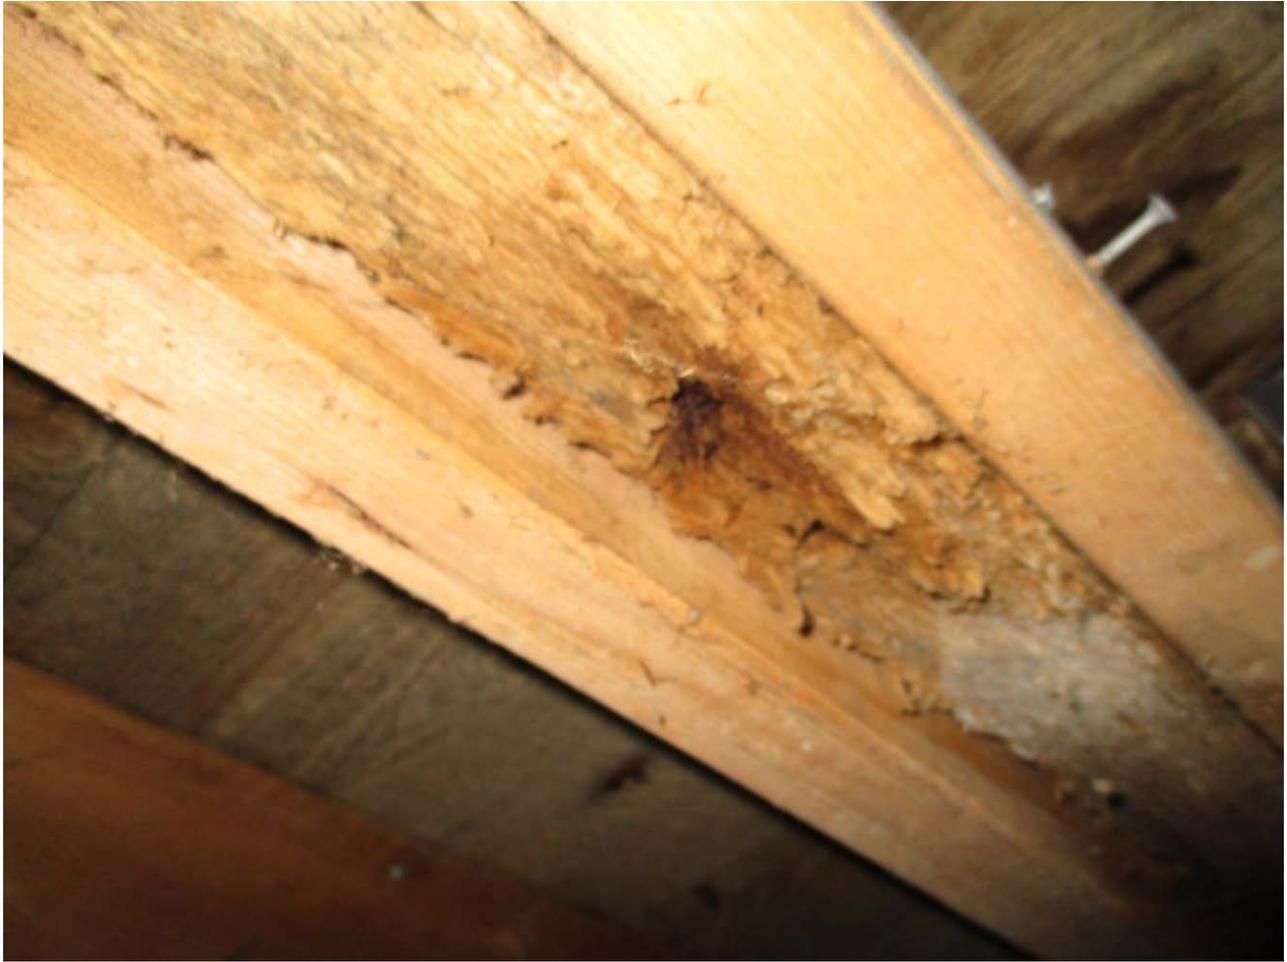
**Picture 28:**

First Floor Framing Deterioration

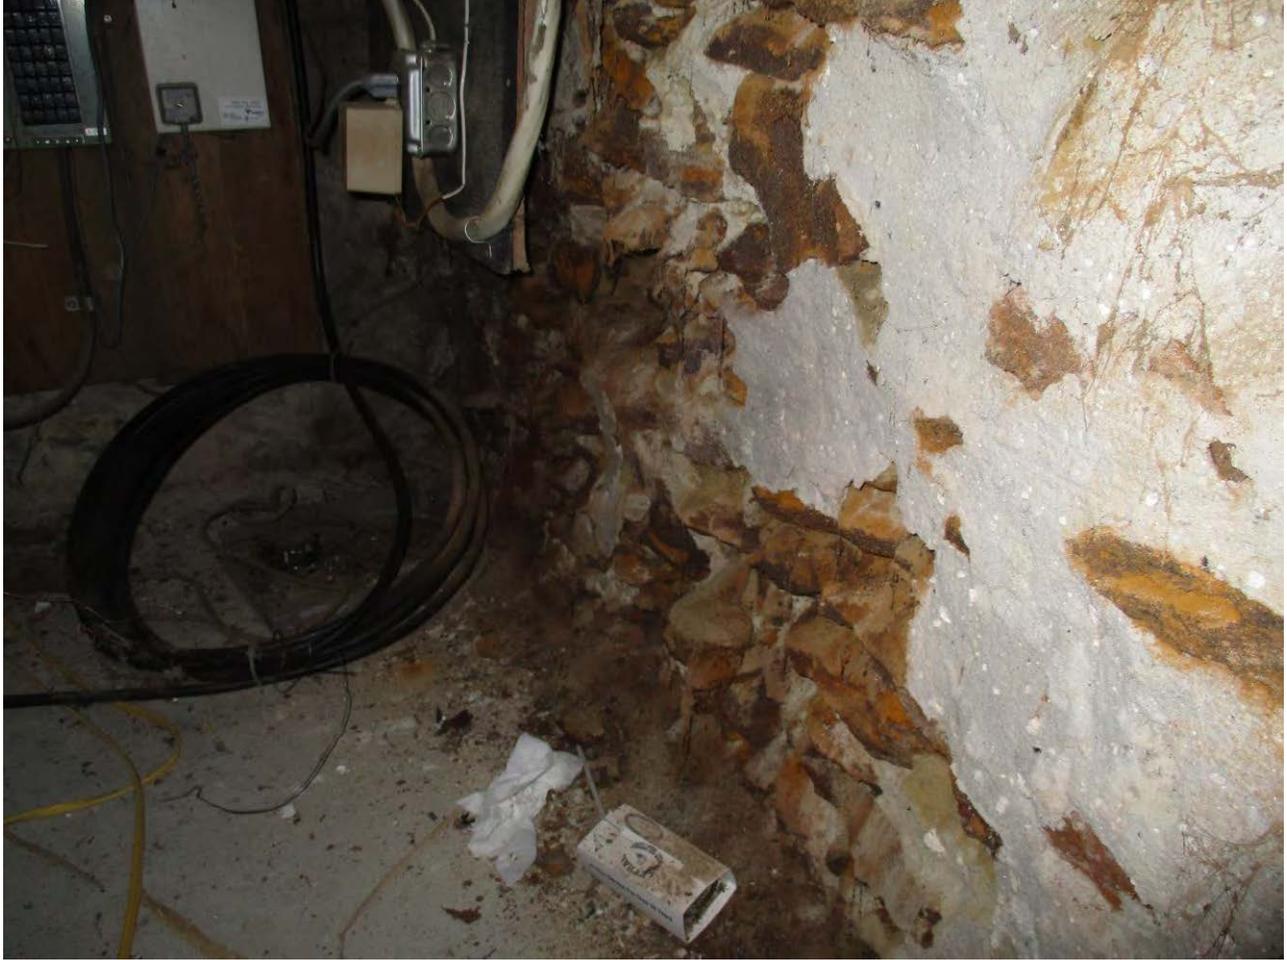
**Picture 29:**

Basement Wall Deterioration

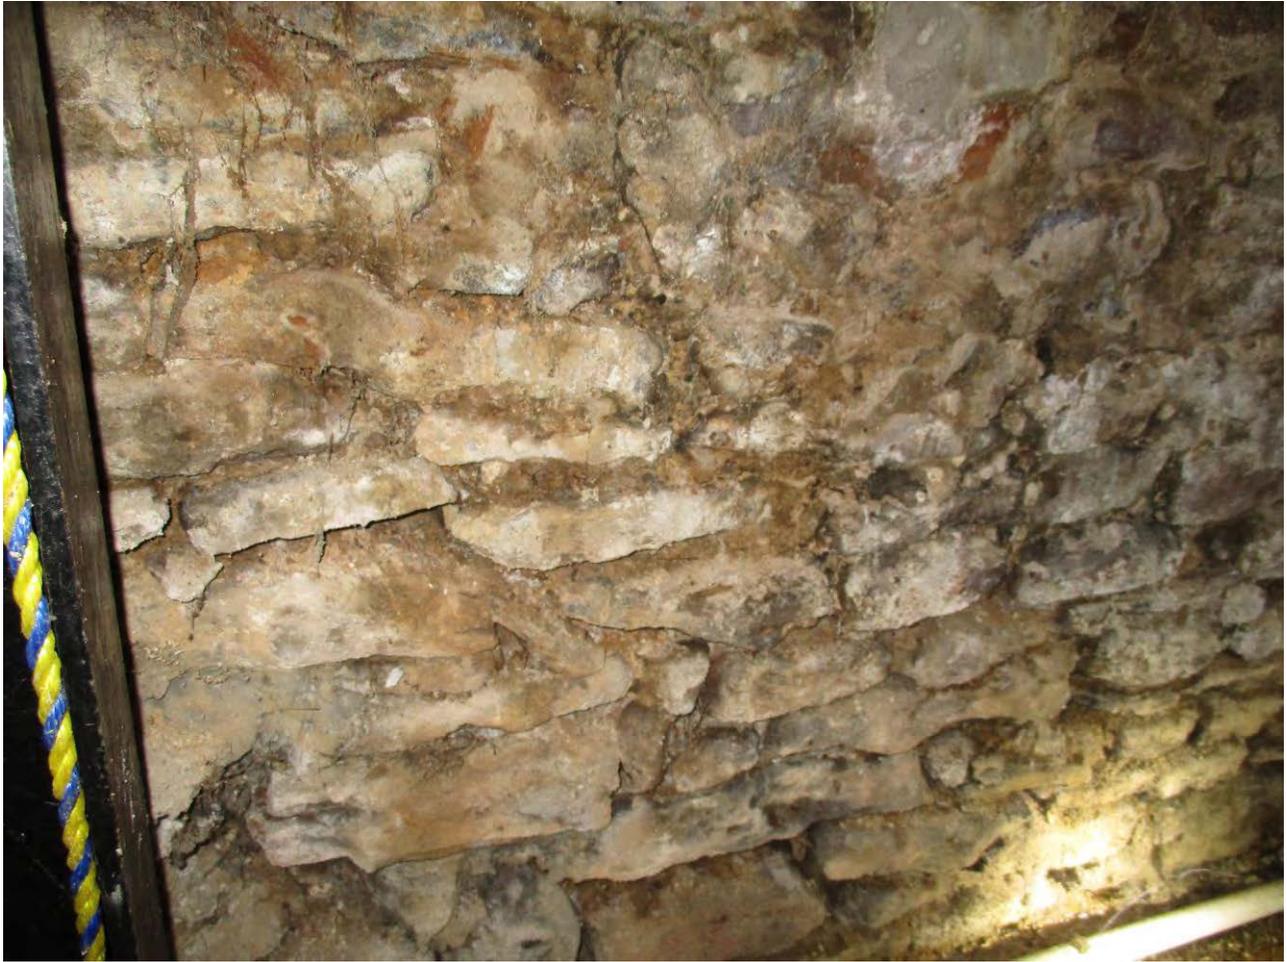
**Picture 30:**

Basement Wall Deterioration

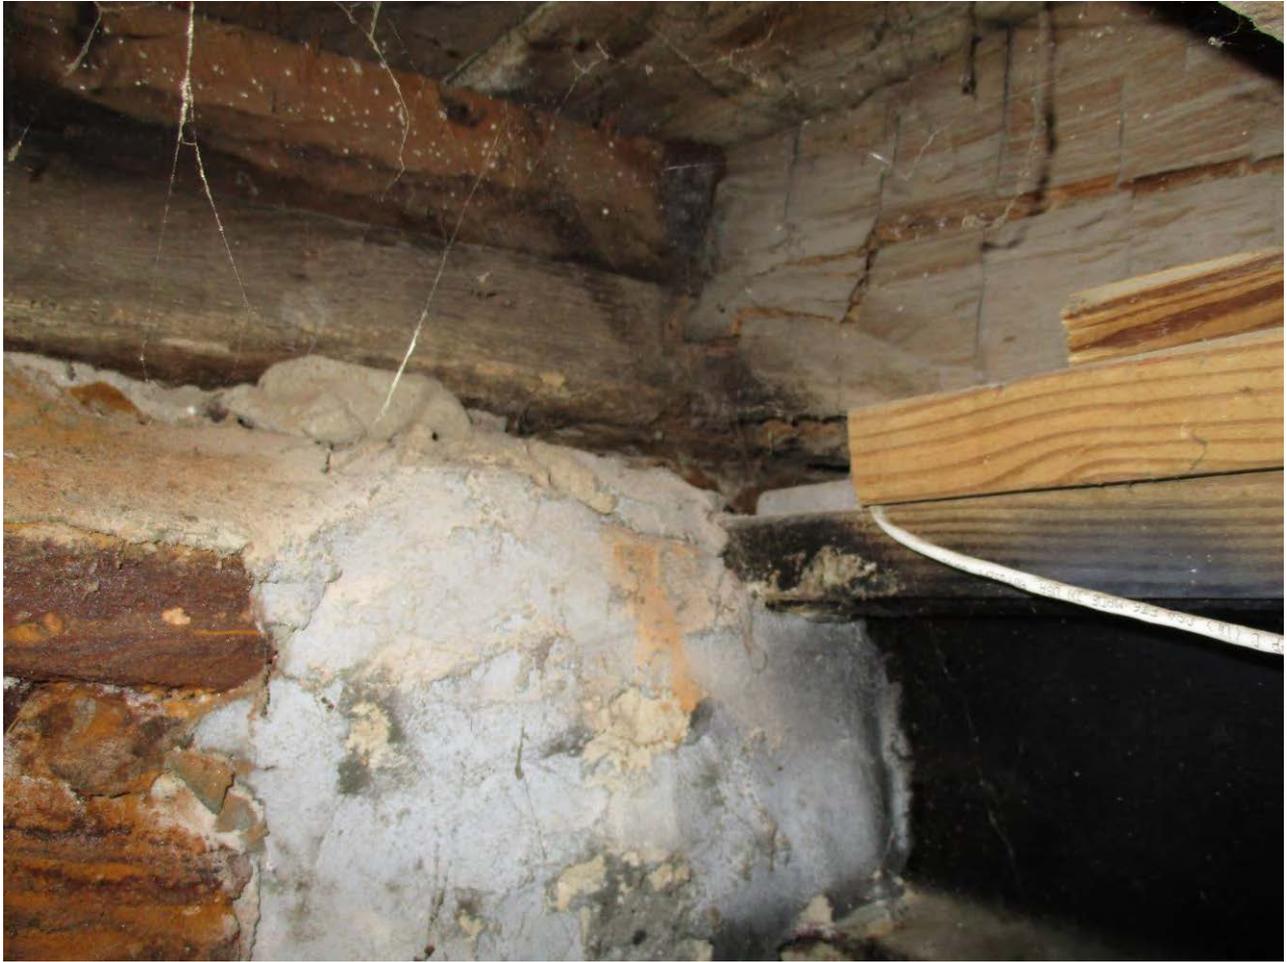
**Picture 31:**

Basement Wall and Wood Framing Deterioration
