# FACILITY ASSESSMENT

## TABERNACLE TOWN HALL

**TOWNSHIP OF TABERNACLE**  
**163 CARRANZA ROAD, TABERNACLE, NEW JERSEY 08088**

**RYEBREAD PROJECT NO. 5665B**

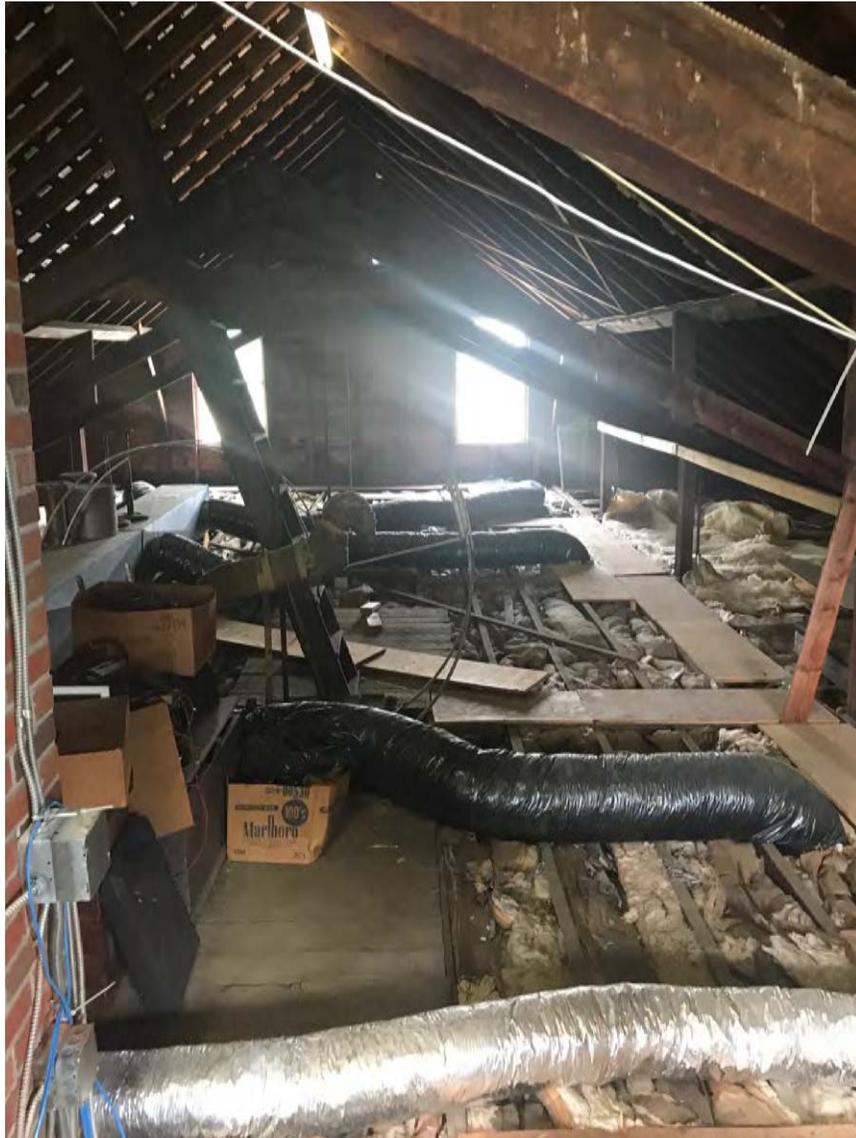
towards the warm side on the space (Meeting Room Side). Incorrectly installed vapor facings can create moisture and deteriorate wood members.

**Recommended Improvements:** Due to the age of the roofing system, all existing roofing and insulation, flashings, gutters, and downspouts should be inspected by a reputable roofing company. A careful investigation of the condition of the roof decking should be conducted. All rainwater now spills on grade, creating a potential safety hazard to the building occupants and visitors and potentially allowing water infiltration into the basement.

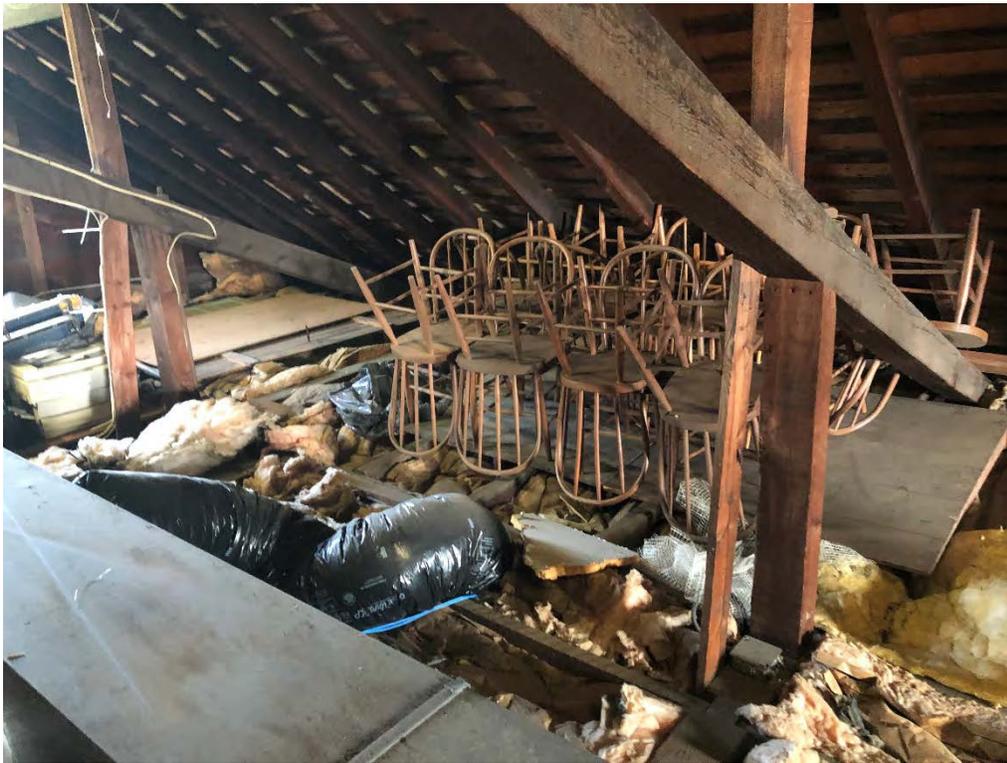
- The building is without benefit of sprinkler coverage. Although the building is understood to be grandfathered in as-is condition, if the facility was built as new, the Second Floor assembly use would dictate the need for suppression.
- Duct penetrations through floor/ceiling assemblies do not have fire dampers, as the floor/ceiling assemblies are not of rated construction. The architectural section may elaborate on rating requirements under their code analysis.

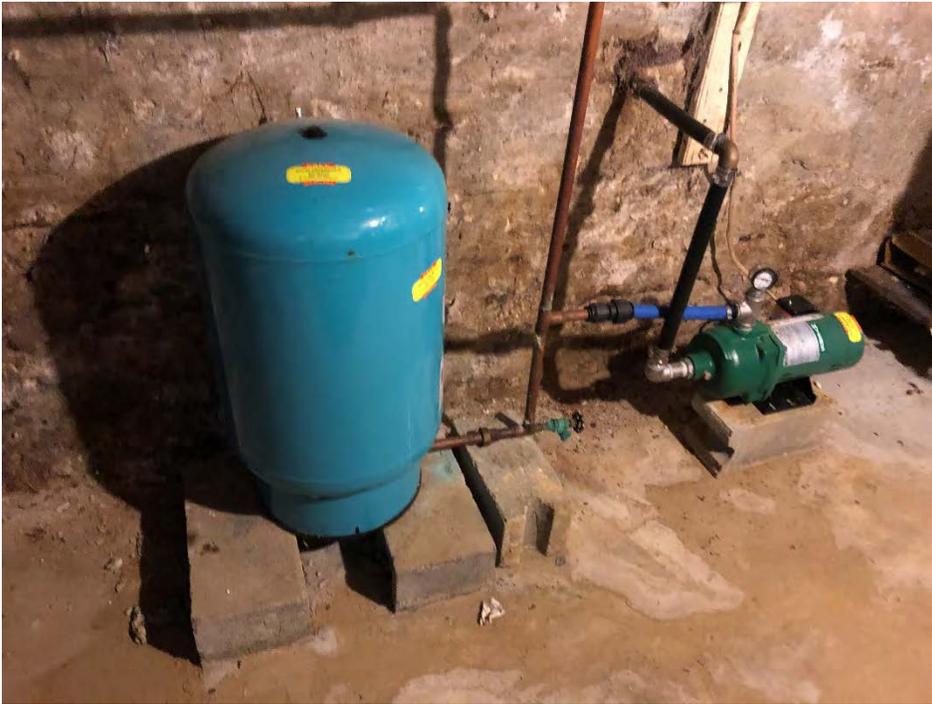
- The domestic water supply for the building is derived from a shallow well water system, which is prone to contamination from the surface. Quality should therefore be monitored on a regular basis until another source is found. The size, capacity and condition of the well was not evaluated under this report. However, no operating problems were brought to our attention.

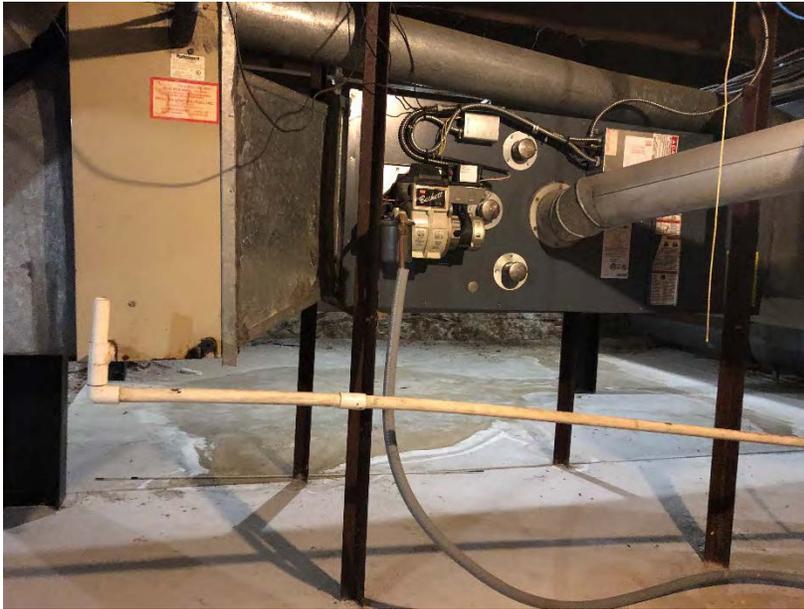
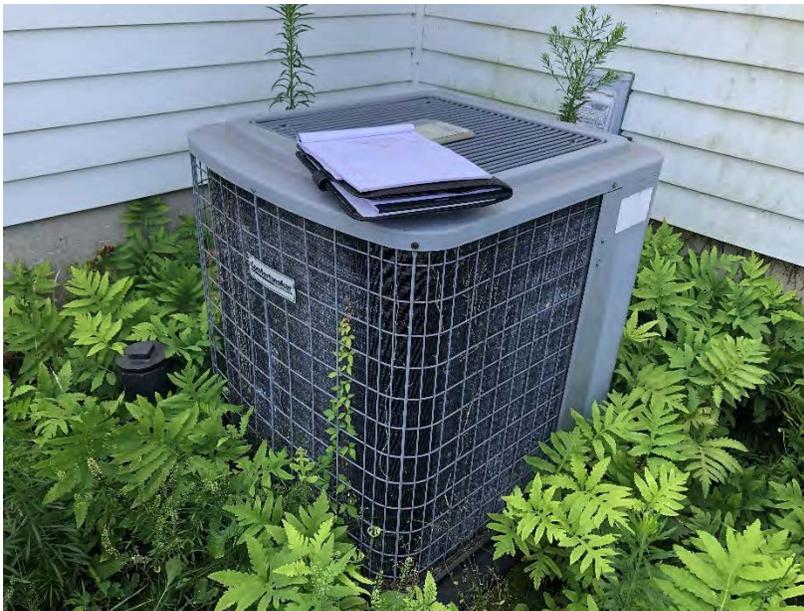
- Heating and cooling for the building is provided by two (2) basement-mounted, oil-fired furnaces, with split direct expansion (DX) cooling systems (indoor evaporator and outdoor condensing unit). The furnaces are located in the open Basement, as opposed to an enclosed furnace room. Without benefit of an enclosed furnace room, the township must take other means to maintain clearance of units from combustible materials. Each unit has a local emergency shutoff switch. However, an additional “break glass” station should be provided at the exit of the Basement.

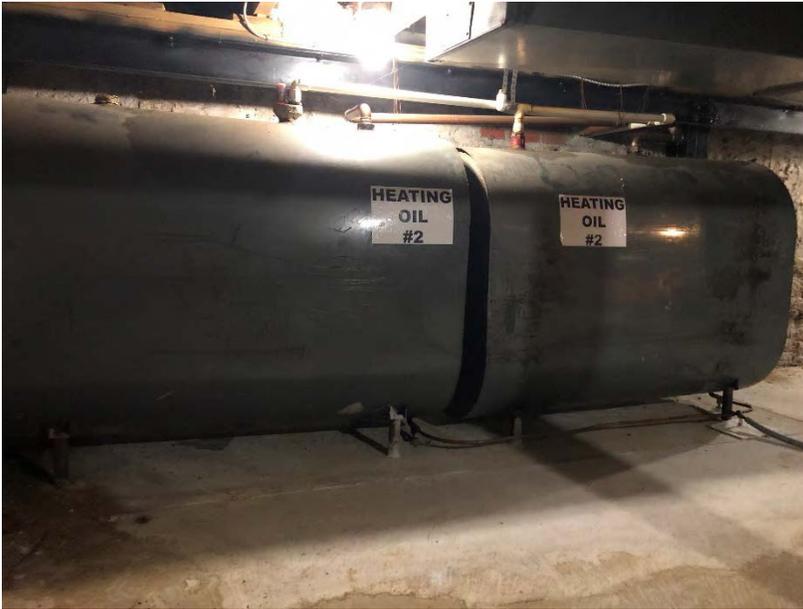
- One (1) HVAC unit serves the First Floor, and the other is for the Second Floor. Both units appear to be in serviceable condition. However, the First Floor unit is reportedly of 1990 vintage, which exceeds a typical twenty (20) year lifecycle by ten (10) years. The Second Floor system was thought to be of 2005 vintage, which would suggest that at least five (5) years of service life remain.
- Fuel oil for the heating system is stored in two (2) basement-mounted tanks. Each tank is of 275 gallon capacity, with single wall steel construction. The tanks are thought to be ten (10) years old, but do not include diking features, leak detection, or an automatic gauging system. The venting system for the tanks makes use of small diameter PVC piping, and the fill lines make use of small diameter copper. Replacement with full tapping size piping of steel construction is recommended.

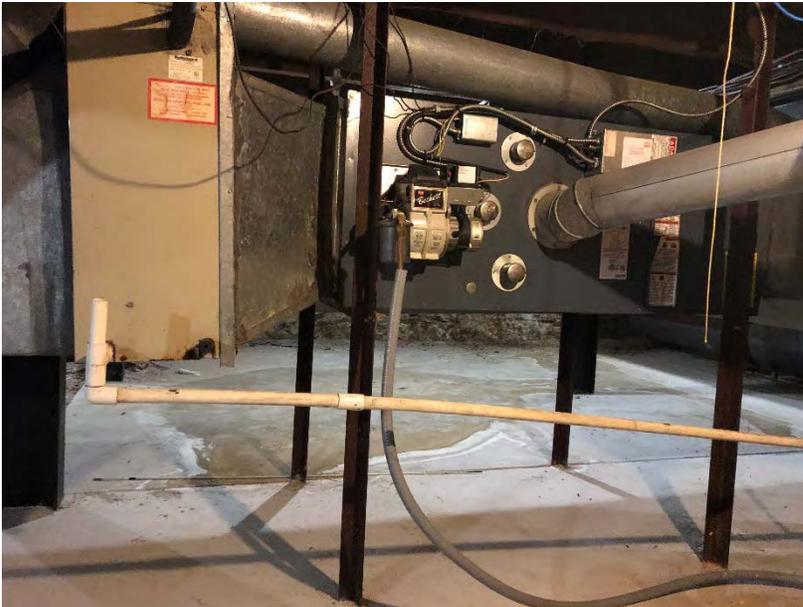
- Flue products from each furnace are ducted to masonry chimney with what appears to be unlabeled, single wall metal pipe. When modernization of the HVAC equipment becomes necessary, the flue pipe should be replaced with labeled materials. In the meantime, the condition of the masonry chimney should be examined.

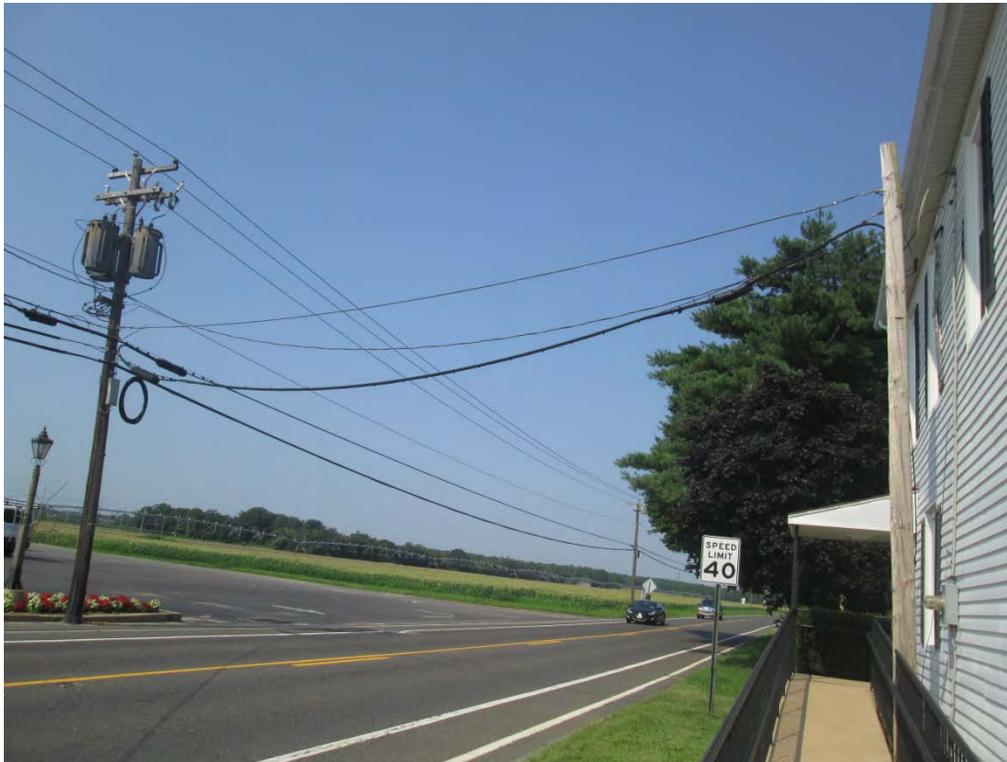
- Electrical service is overhead from pole mounted transformers. Service size is 200 amps at 208/120 volt, single phase, three wire. The utility company meter is on the exterior, with the main electrical panels located in the Basement.

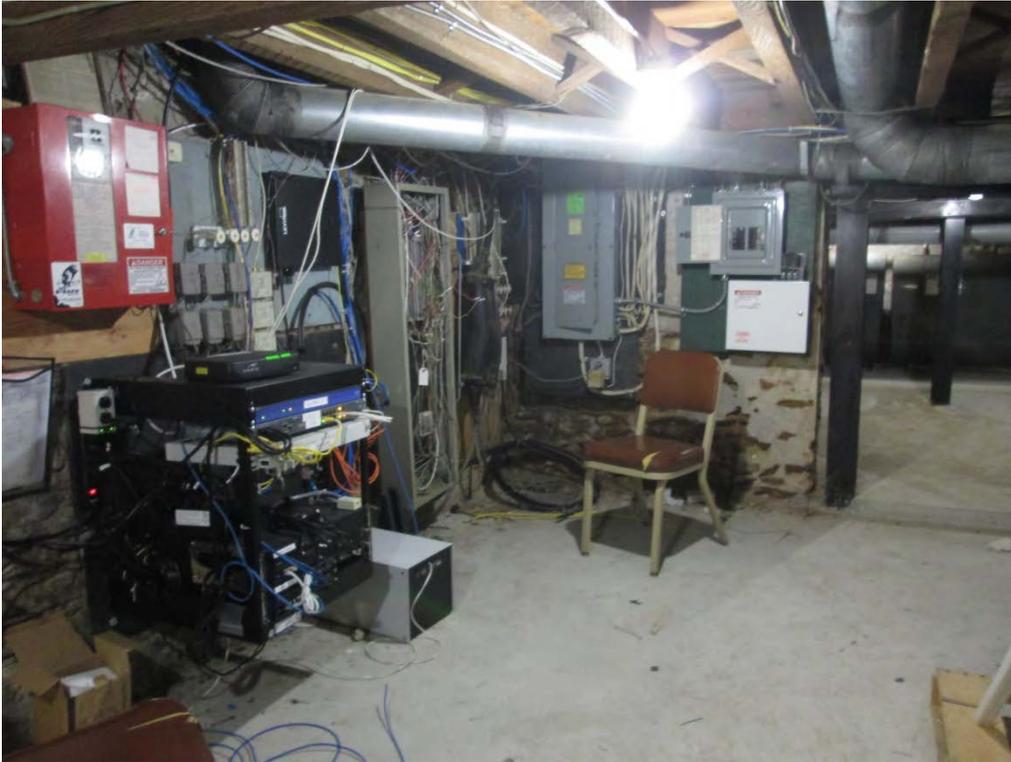
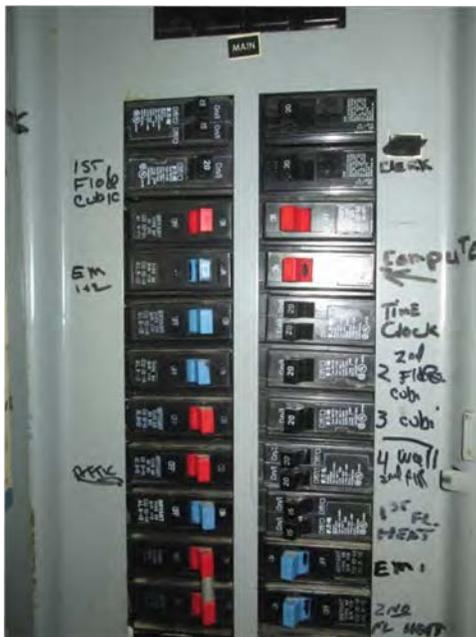
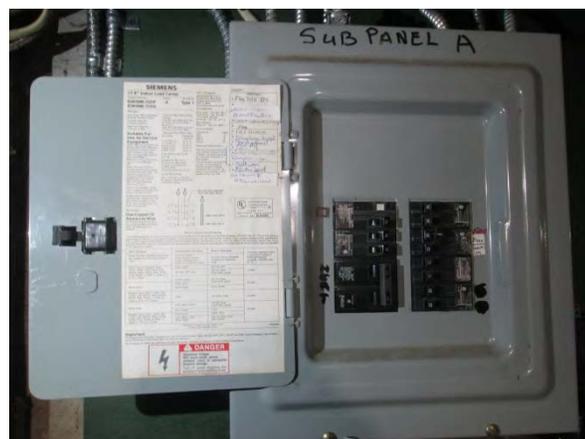
- The main electrical panel is an older ITE unit, with a 200 amp main circuit breaker. While the breakers themselves appear to be in reasonably good external condition, the panel is rusty from the water infiltration and needs to be replaced. It feeds an adjacent newer Siemens sub-panel to provide additional breaker positions. Both panels contain several tandem breaker units (i.e. two physically smaller breakers, squeezed into a single breaker position). When the panels are replaced, it's recommended to provide sufficient pole positions to avoid the use of tandem breakers.

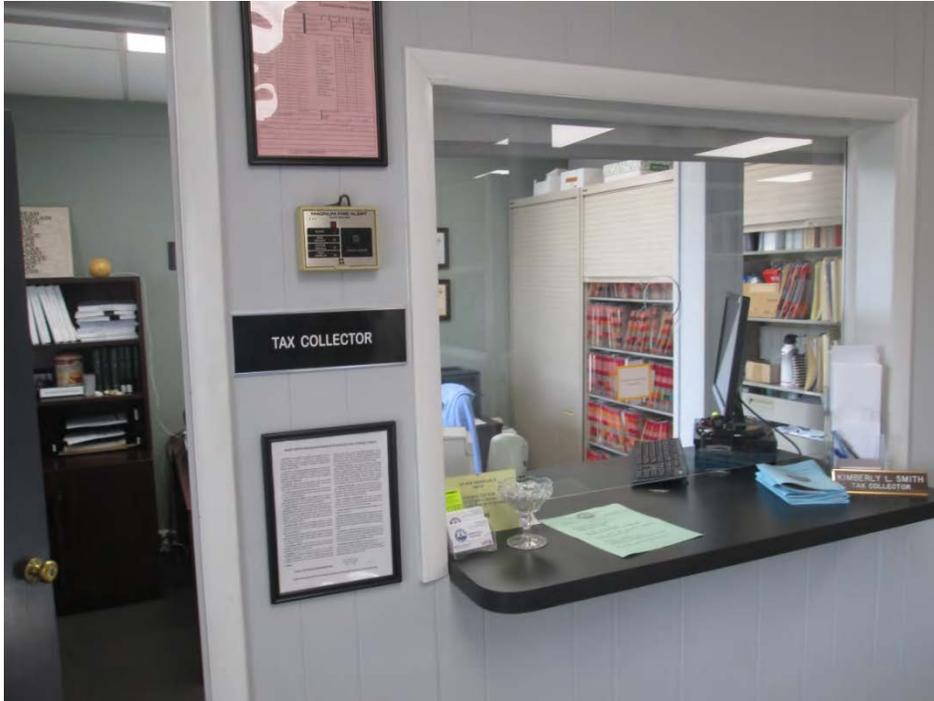
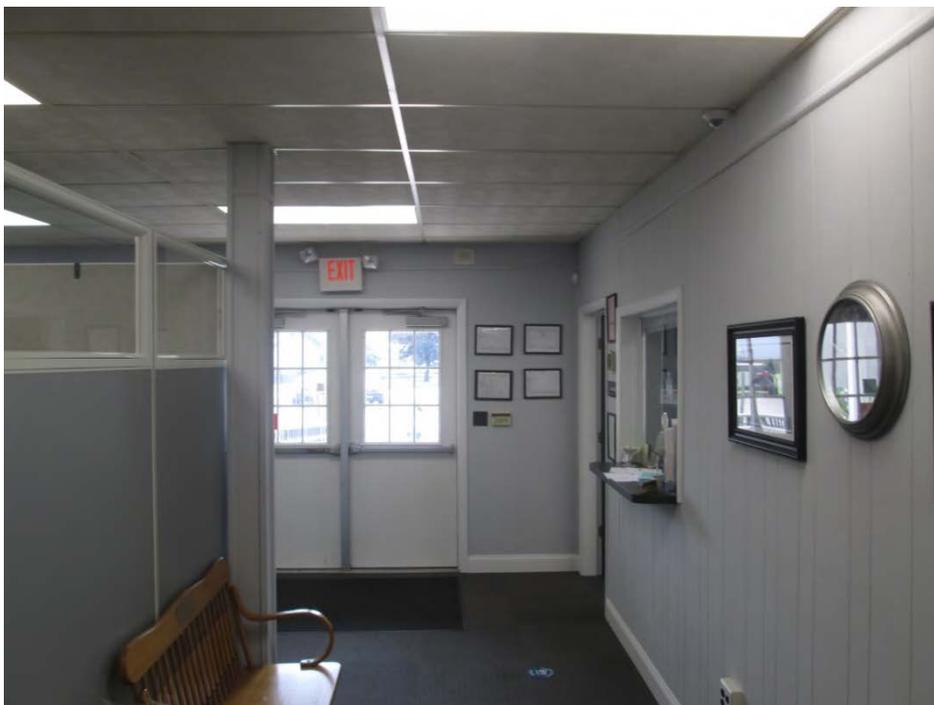
- Lighting levels appear adequate in occupied spaces. Emergency egress lighting is provided by wall mounted battery pack units. The Attic would likely be poorly lit without benefit of daylight entering the windows, and is need of egress lighting.

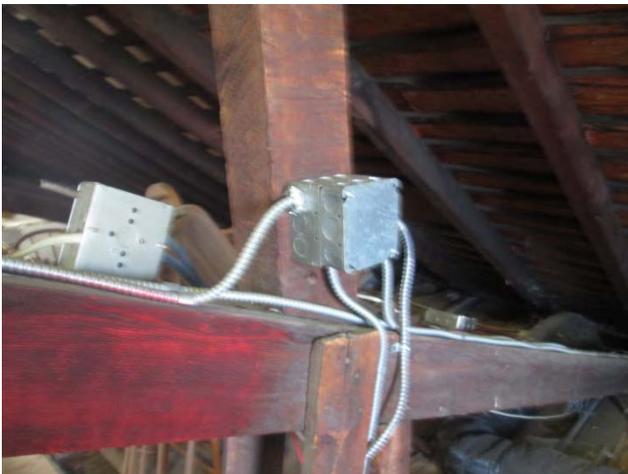
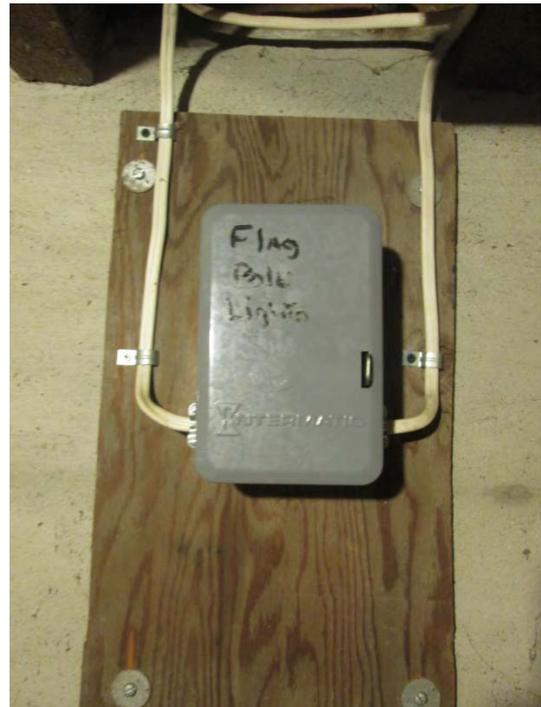
- Observed wiring is a combination of conduit, MC/AC cabling (BX), and NM (Romex), and appears to be in good condition. Normally NM wiring is not permitted for places of assembly (100 or more), however it is permitted for buildings of non-fire rated construction.

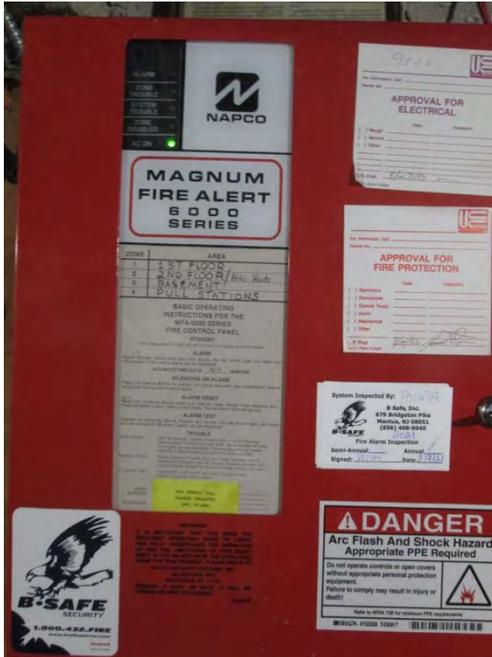
- The fire alarm system is a Napco Magnum Fire Alert 6000 Series. It's a conventionally zoned system, with four (4) separate zones for detectors on 1st floor, 2nd floor, basement, and pull stations. Conventionally zoned systems have become all but obsolete, as small addressable systems have become economically feasible for even small buildings. Therefore, the next future fire alarm upgrade should be to a small addressable system.
